Home Inspection Report

Property Located At
10 Moana Grove
Tawa, Wellington
New Zealand

Inspection Date: 24th June 2013
Inspected By: Mark Sewell
Report No.: RPT118

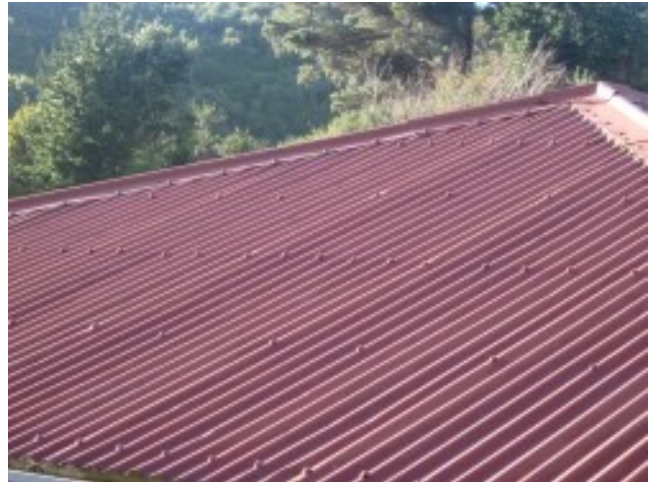
The roof does appear in reasonable overall condition

The roof is well fixed in place noted

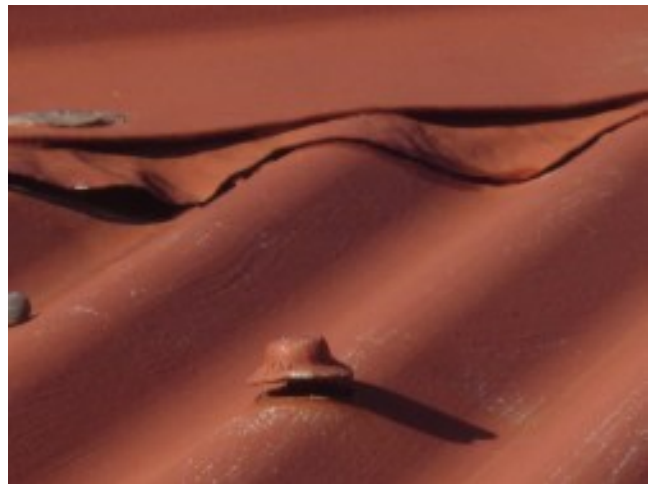
Lead heads have come away in areas and will need attention

Many older roof fixings need re-sealing in place noted

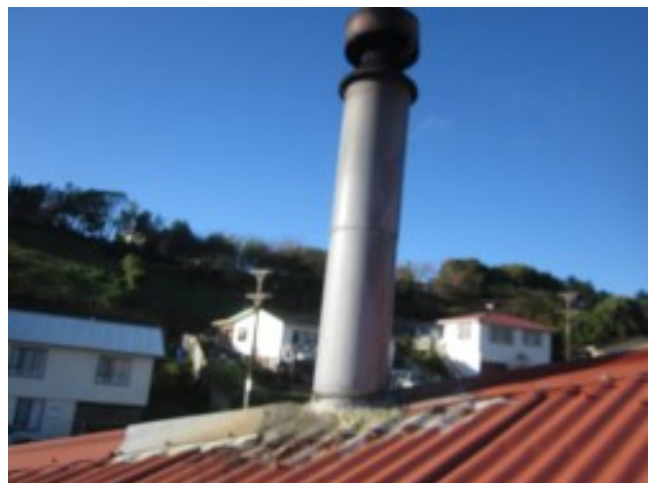
The valley flashing is well fixed in place and in good order

Flue to wood burner appears in reasonable condition

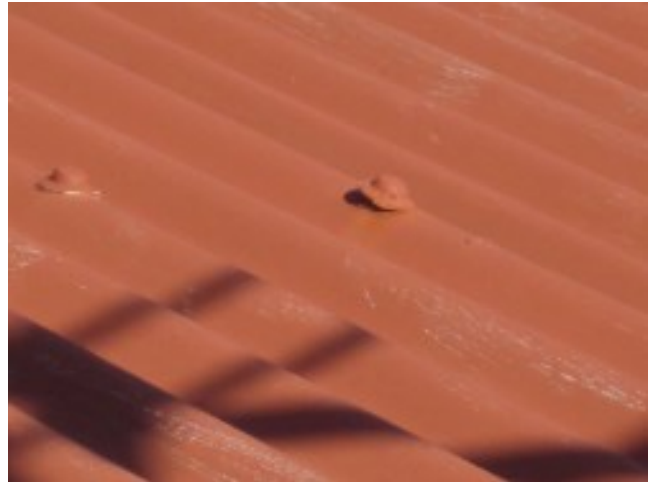
The odd roof fixing is leaking and will need attention

Recommend up grading older type lead head roof fixings

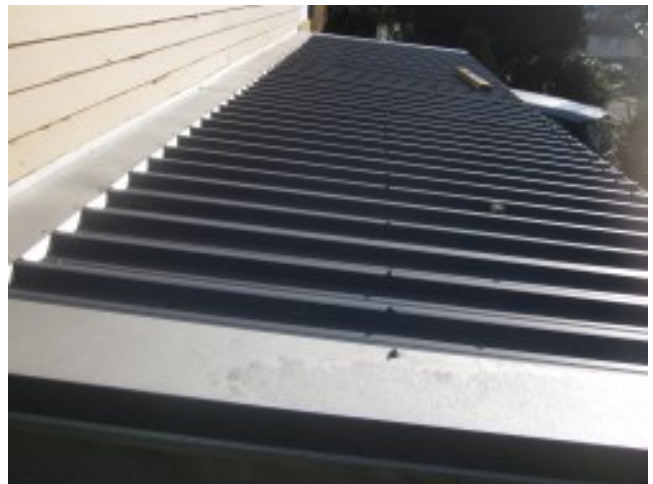
The ridge flashings appear in reasonable condition

Lower garage roof area appears in reasonable condition

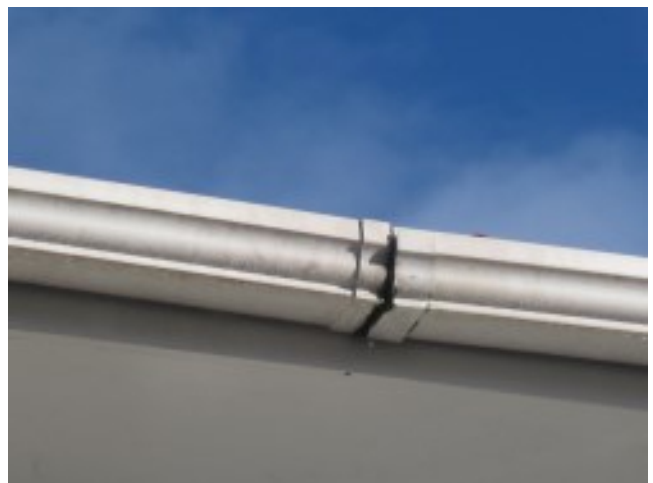
The roof and cladding junction appears well detailed

Spouting is leaking at this junction, will need attention

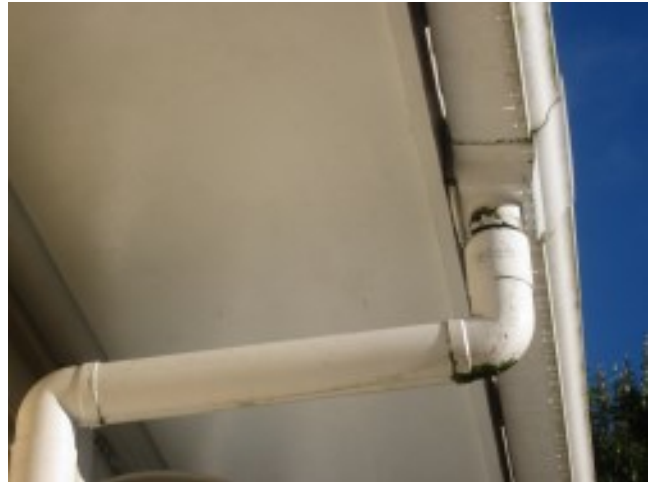
Lower spouting to the garage area is leaking and will need attention

Downpipe needs re-fixing to spouting at this junction

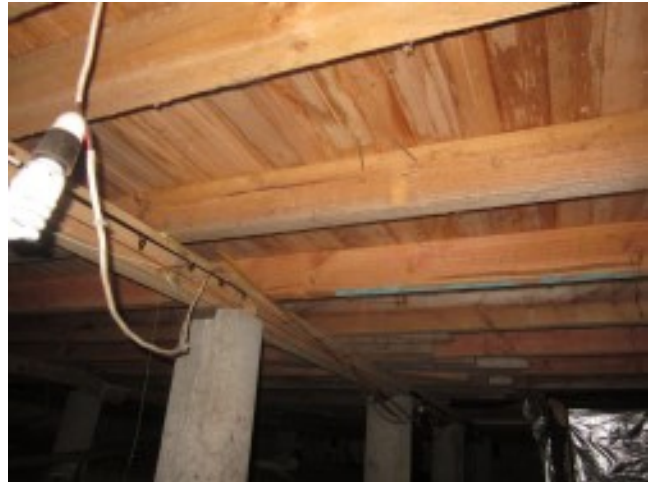
No insulation to the ceiling space noted, but recommended

No insulation to the subfloor area, but is recommended

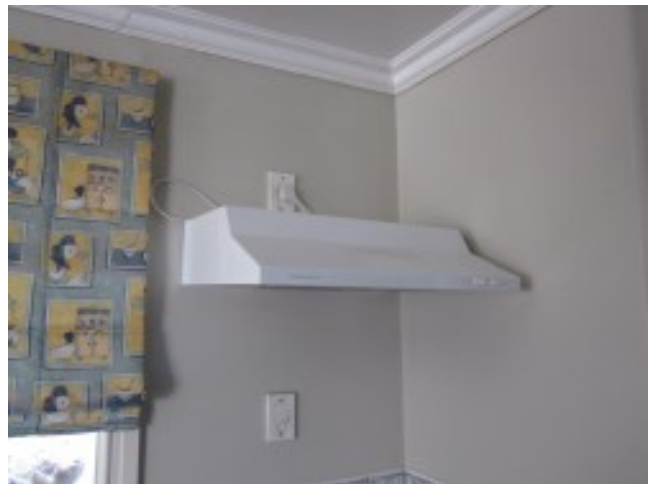
Bathroom fan needs venting to the exterior noted

Kitchen range hood appears in reasonable order

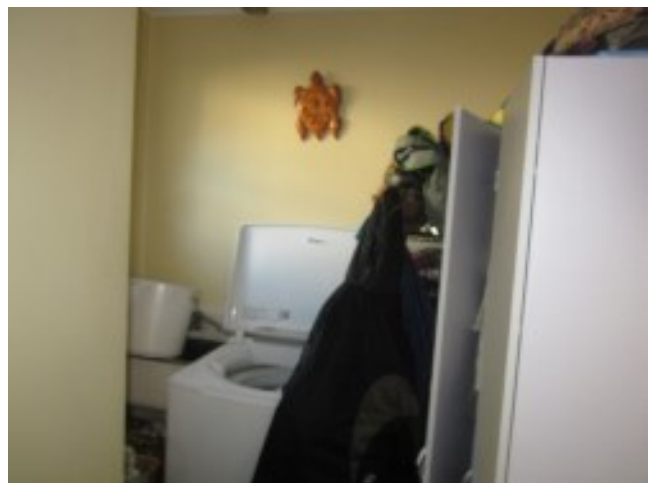
Recessed light fittings appear in good order

No dryer vent noted, but recommended

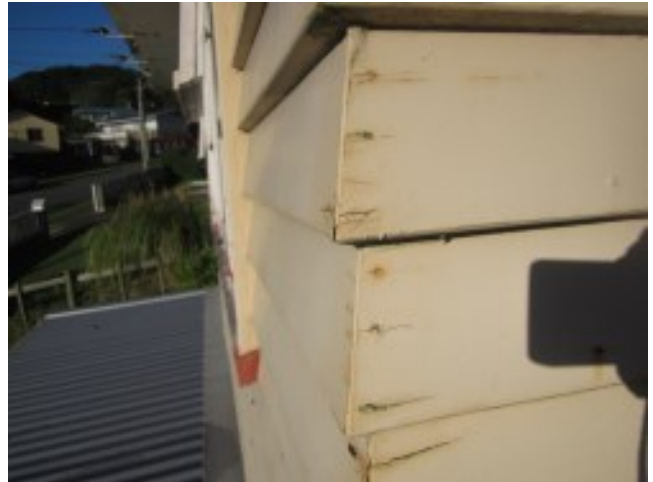
The exterior cladding requires maintenance in many areas noted

Many external cladding junctions need re-sealing

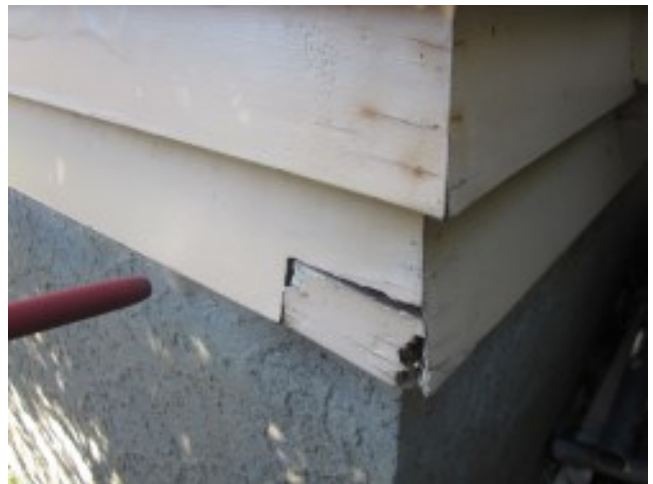
Lower door sill needs re-painting

Weather boards show rot in places and will need attention

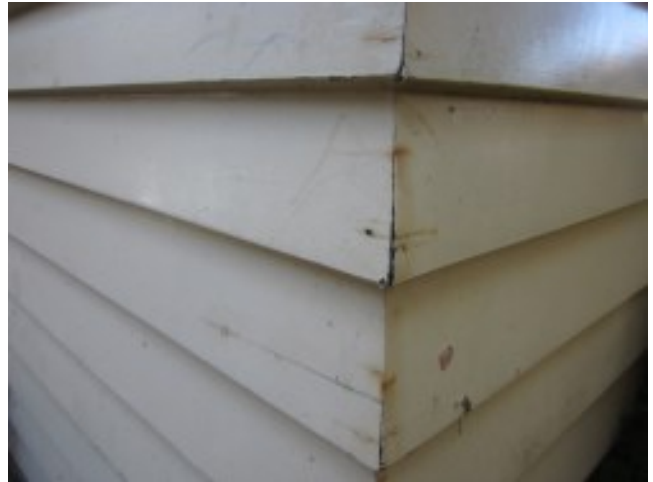
Paint has come away in many areas, will need attention

Recommend boxed corners be installed to external junctions

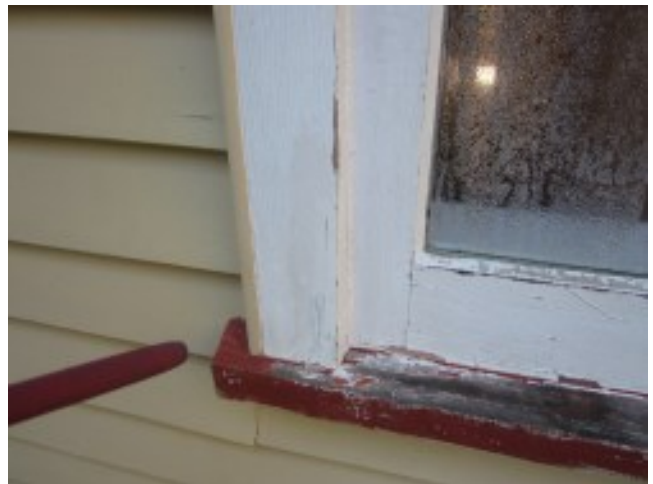
Rot noted to some weather boards will need attention

All exterior window frames need re-painting

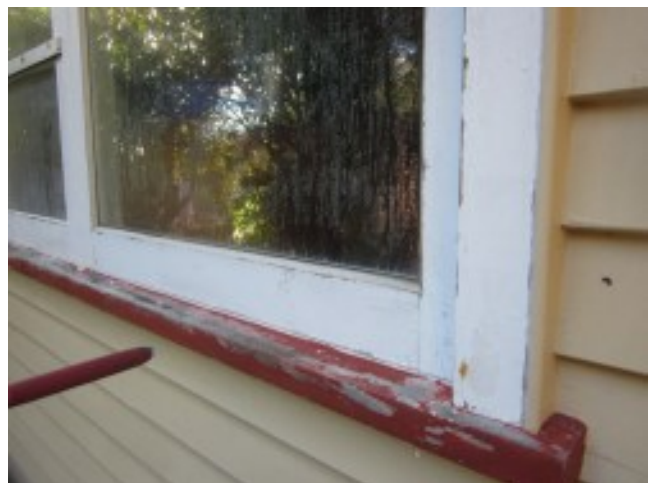
Many weather board junctions need re-sealing noted

Window frames need maintenance and re-painting

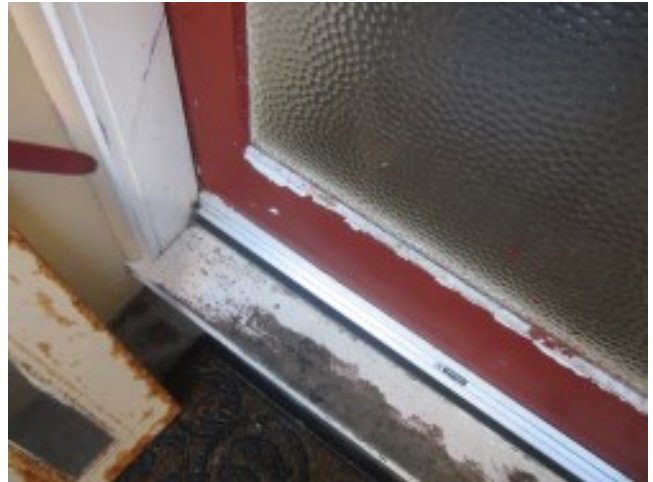
Paint wear to many areas of cladding noted, will need attention

Lower door sill is showing wear, will need attention

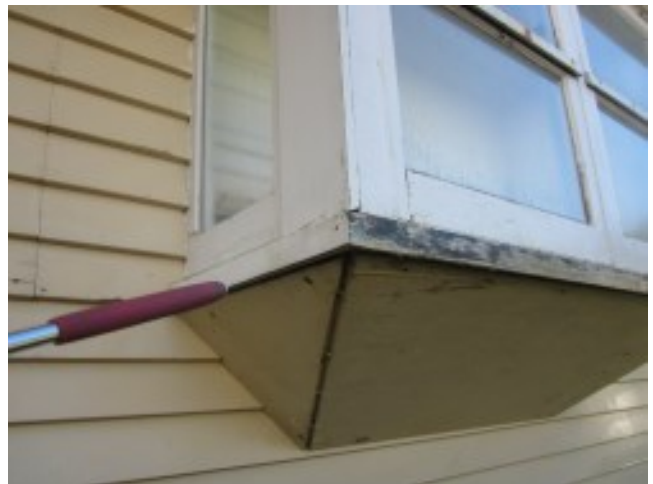
Rusted fixings noted to many windows, will need attention

Lower bay windows is poorly finished, will need attention

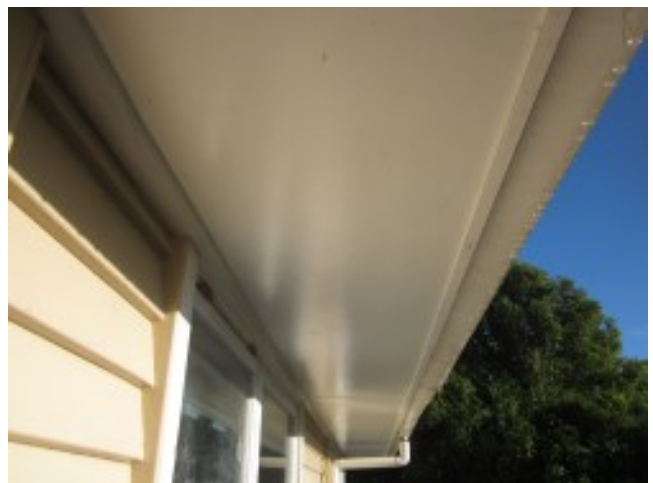
Timber trim needs re-sealing in areas noted

Soffit and cladding junctions appear well sealed

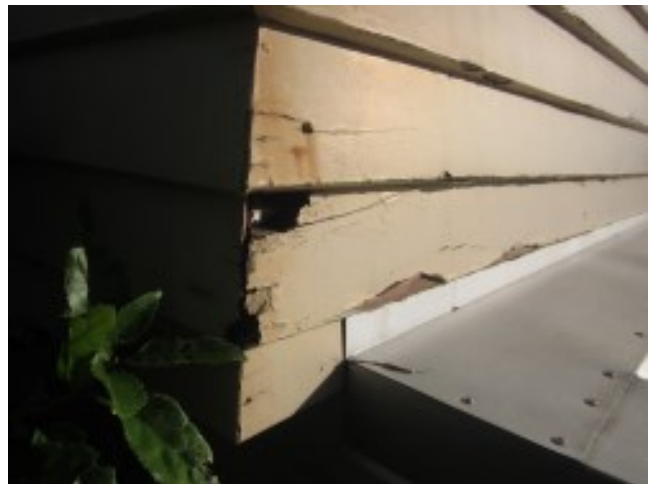
Lower base cladding appears in reasonable order

Rot to weather board noted, will need attention

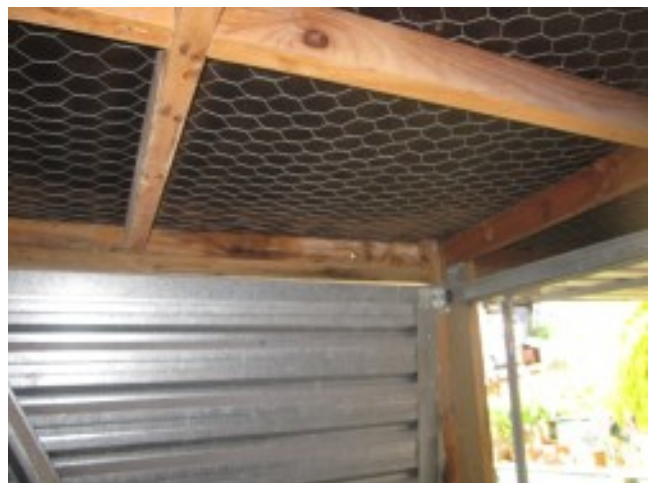
Paint wear noted to all areas of weather board, needs re-painting

The garage extension is not done to tradesman like manner

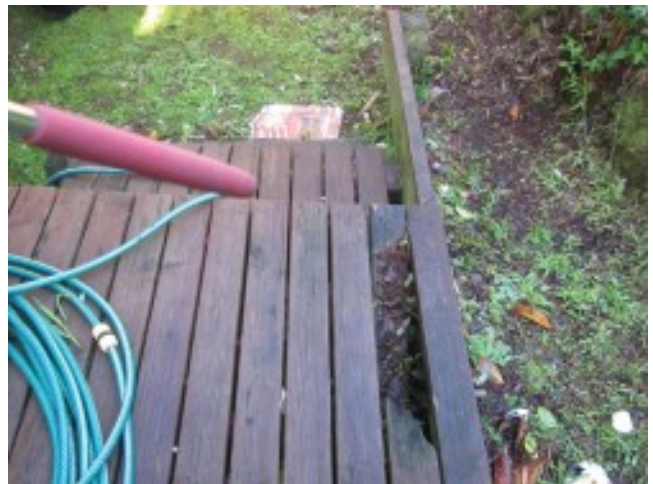
Rear deck area requires maintenance in areas

Decking needs attention in areas noted

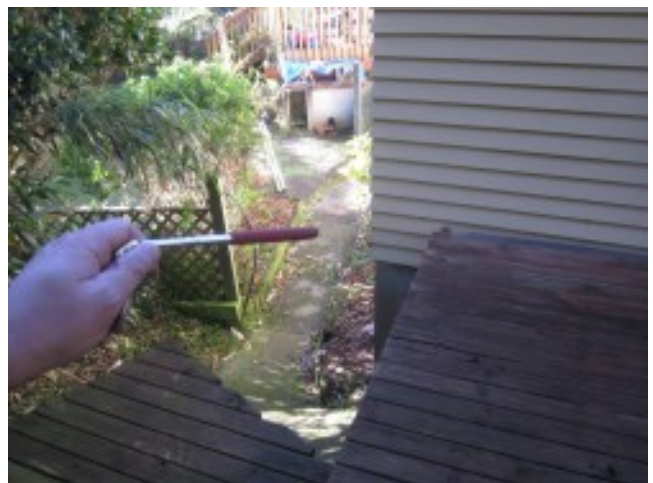
decking to cladding junction needs attention

Recommend deck rail to high side of the deck

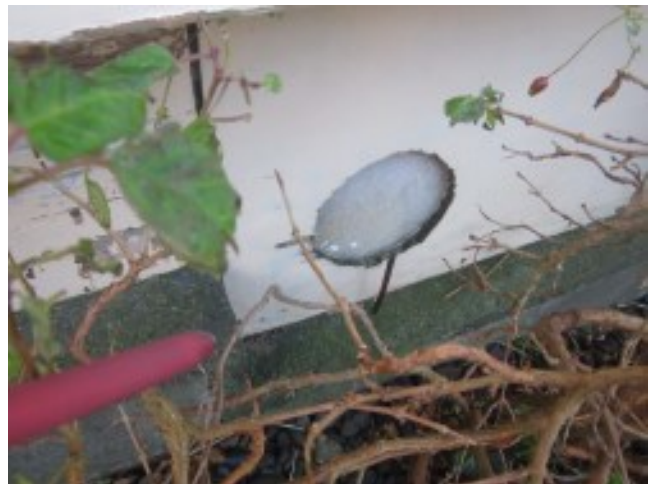
The grounds appear well developed and well maintained

Large hole noted to lower base cladding noted

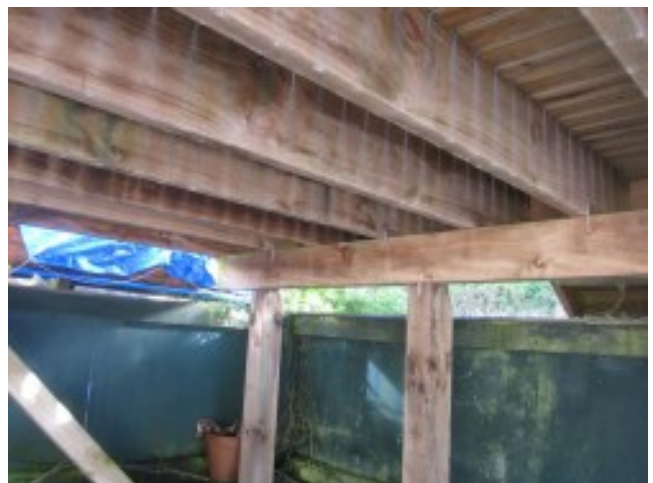
Exterior cladding junctions need attention in many areas noted

Under side of newer deck area is in good condition

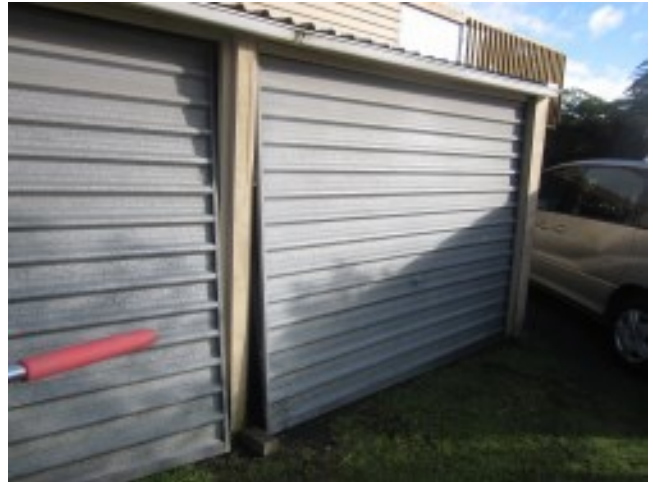
Recommend bowmac bracket and bolts to posts and deck joists junctions. Garage doors don't shut as framing has twisted, needs attention

Gravel drive way area noted, appears in reasonable order

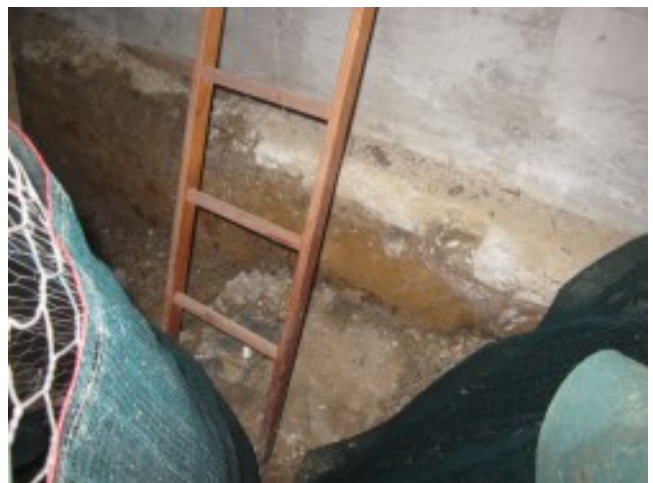
Moisture noted to lower foundation area, will need attention

The concrete ring foundation has been under mined, needs attention

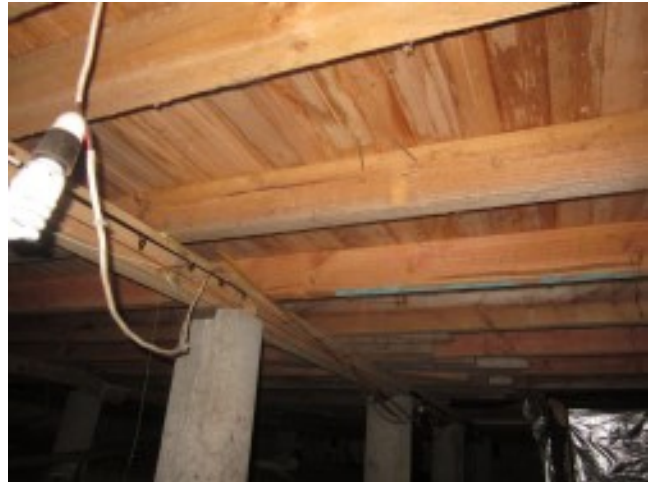
Bank has been cut to close to lower pile, will need attention

Bearers and floor joists appear in good condition

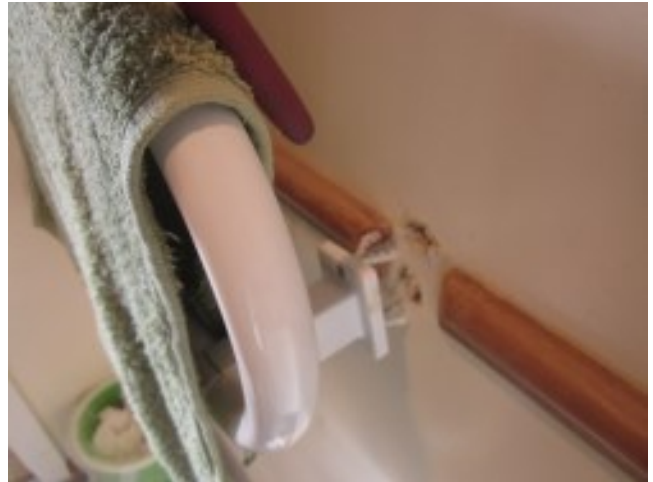
Heated towel rail appears in reasonable condition

Towel rail bracket needs re-fixing at the wall junction

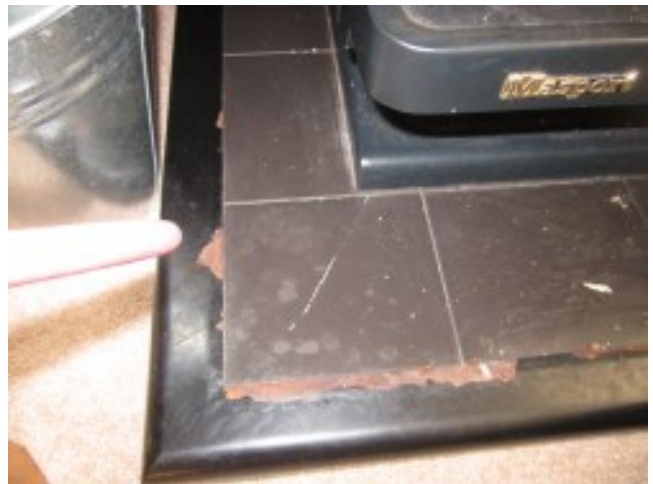
Wood burner noted appears in reasonable condition

Cracked tiles noted to lower wood burner area

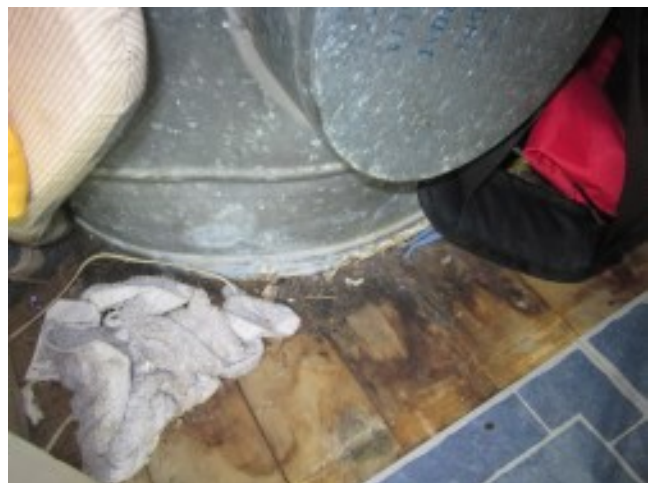
Older low pressure hot water cylinder is leaking, needs attention

Cylinder is leaking, will need up grading

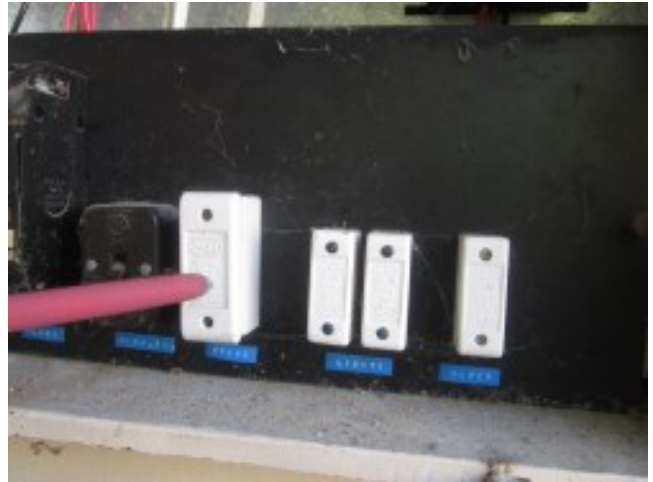
Meter and switch board appears in reasonable condition

Recommend up grading older type fuses

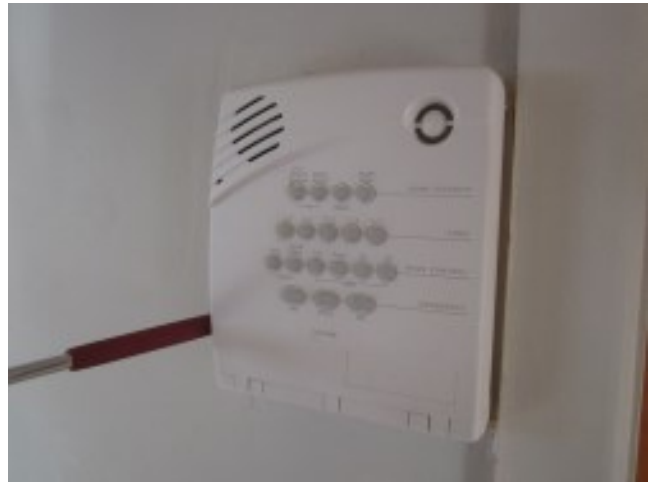
Meter cover shows rust, will need attention

Alarm system noted, but not tested

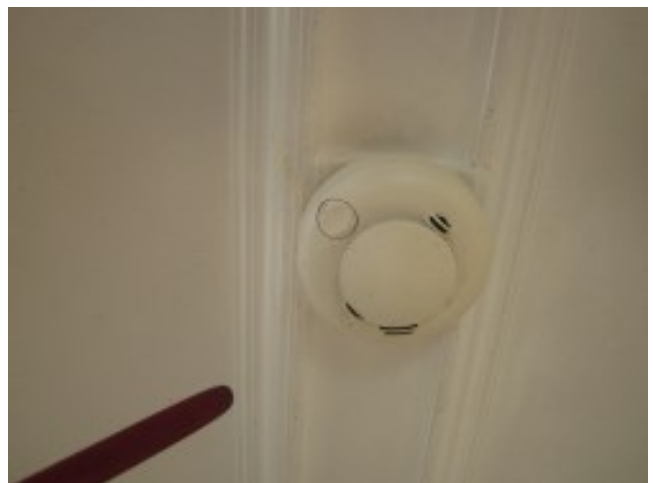
Bathroom fan appears in good working order

Smoke alarms noted, but not tested

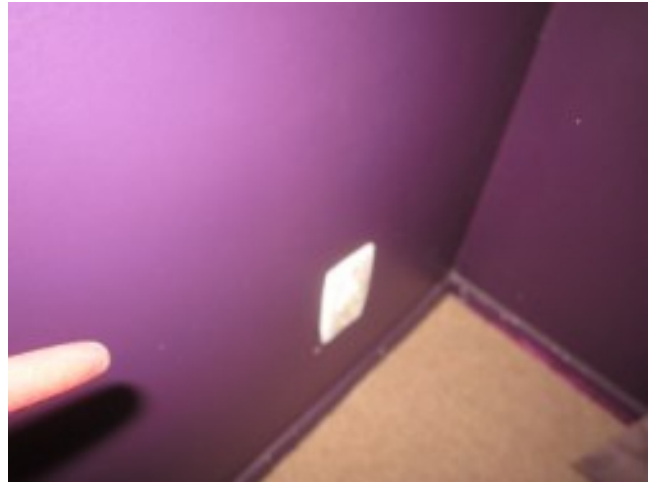
Interior light fittings appear in reasonable condition

The odd switch needs re-fixing at the wall junction

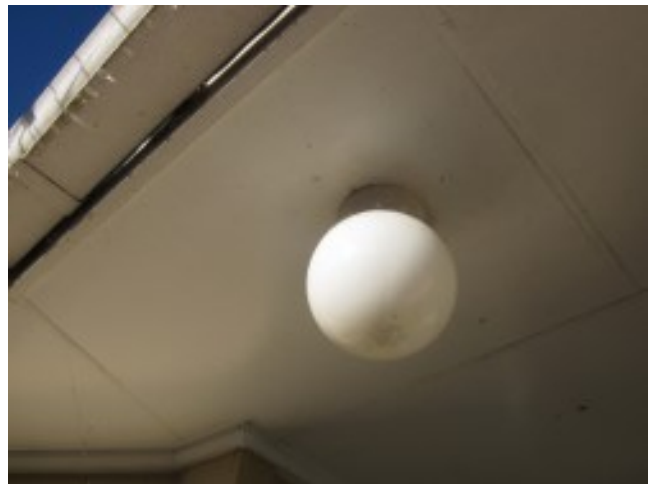
The odd switch needs re-fixing at the wall junction

Exterior light fittings appear in reasonable condition

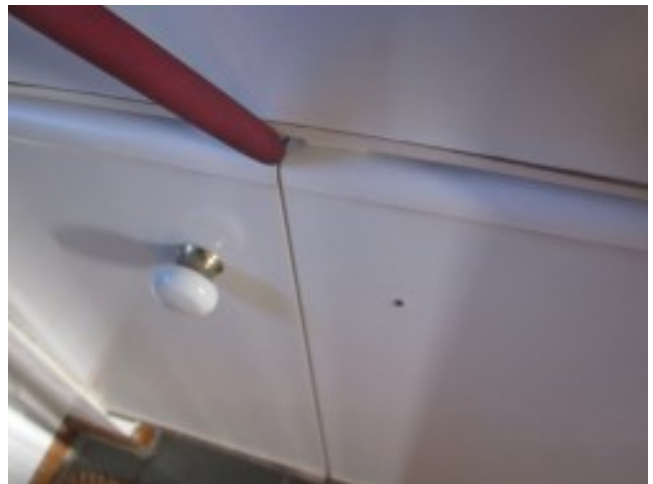
Mould noted to silicone, will need attention

Door handle to vanity needs replacing

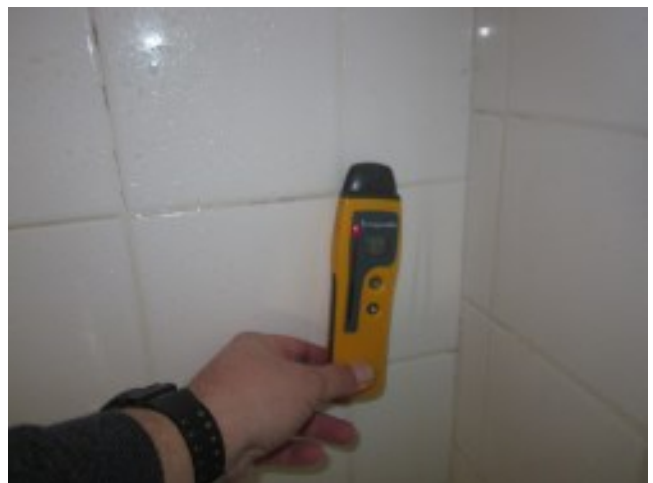
Lower vanity shows water damage noted

High moisture reading to shower wall, will need attention

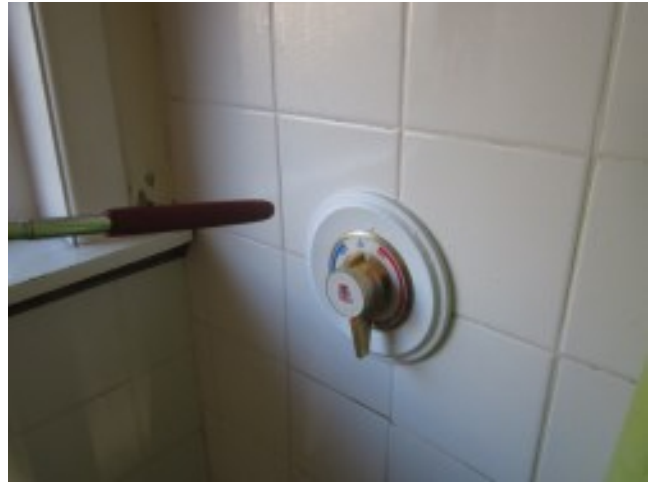
High moisture readings to shower wall, needs attention

Tile need re-grouting in areas noted

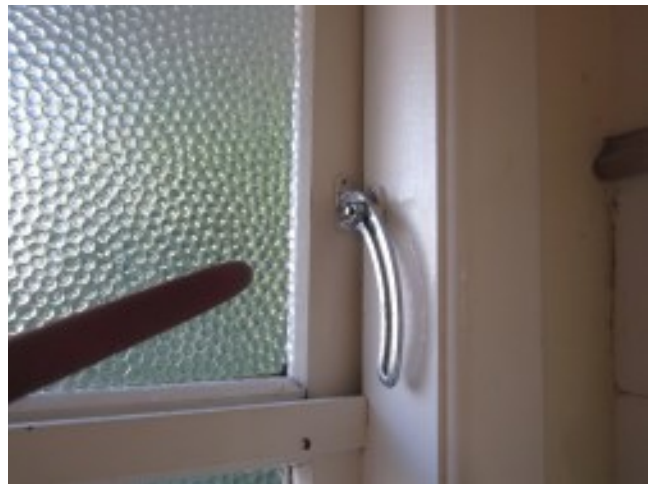
Moisture damage to window frame and wall, needs attention

The window needs easing, very common for timber joinery

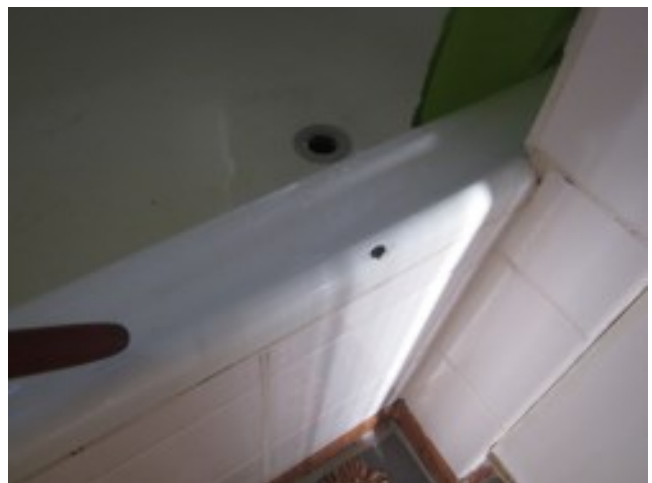
Bath taps are poorly sealed at the wall junction, needs attention

Minor wear noted to the bath in areas noted

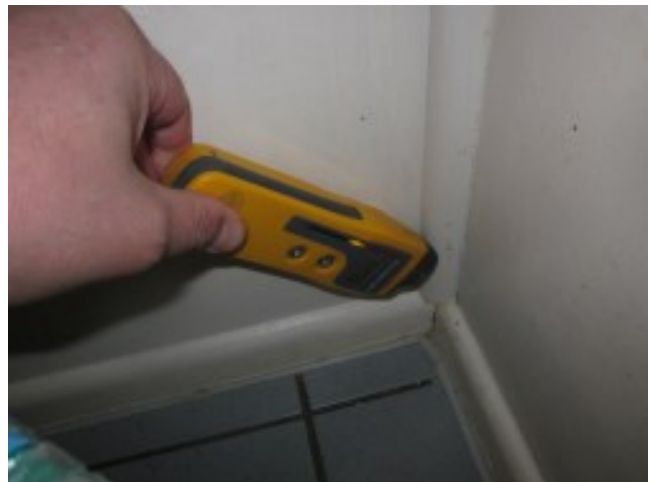
Toilet pan needs re-fixing and re-sealing at the cladding junction

High moisture reading to lower exterior wall, needs attention

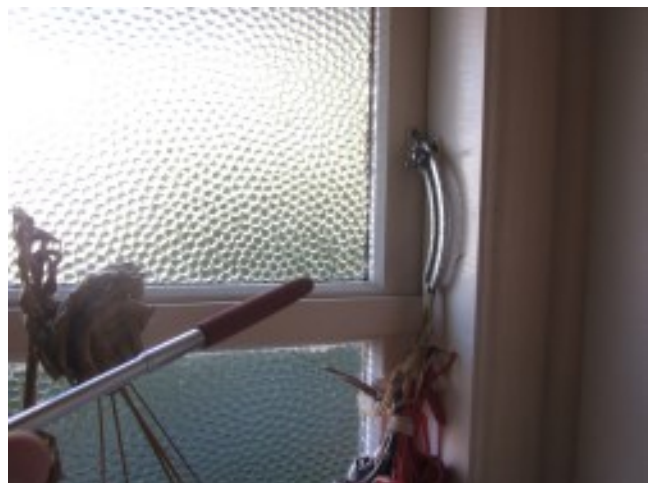
Door handle needs re-placing noted

Window needs easing, very common for timber joinery

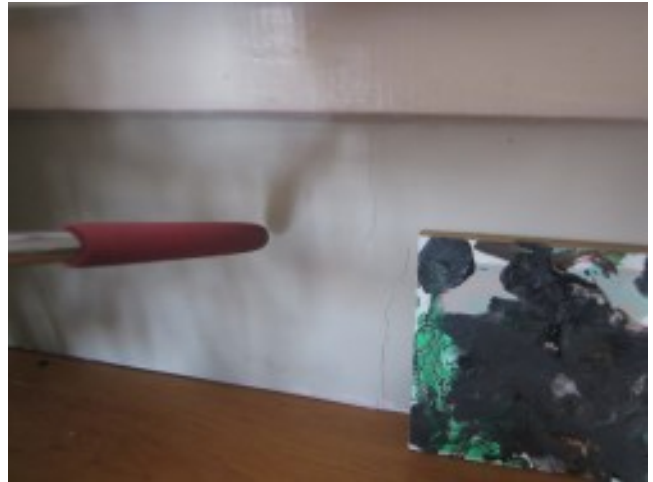
The kitchen appears is reasonable condition

Movement cracking noted, very common to most homes

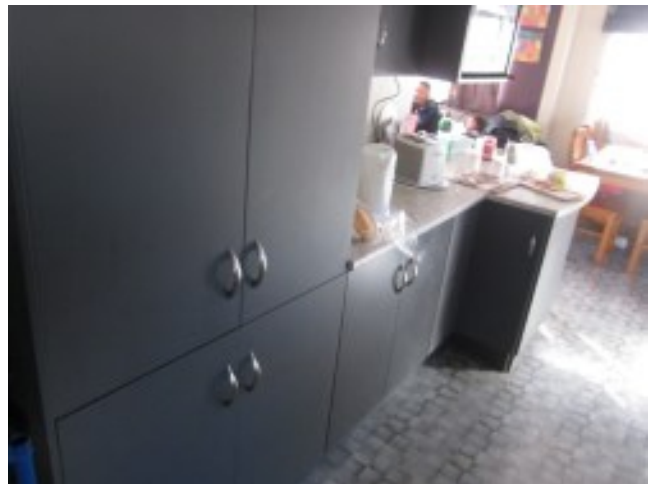
Wear noted to the vinyl in areas

The kitchen joinery appears in good condition

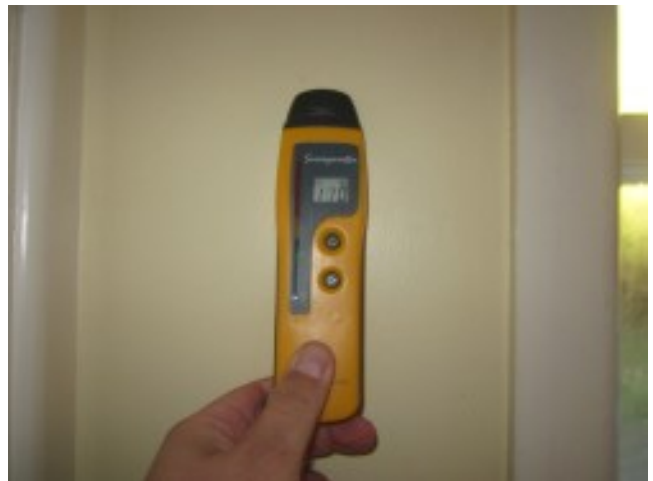
The laundry appears in reasonable condition

Moisture fluctuations to exterior walls appear normal

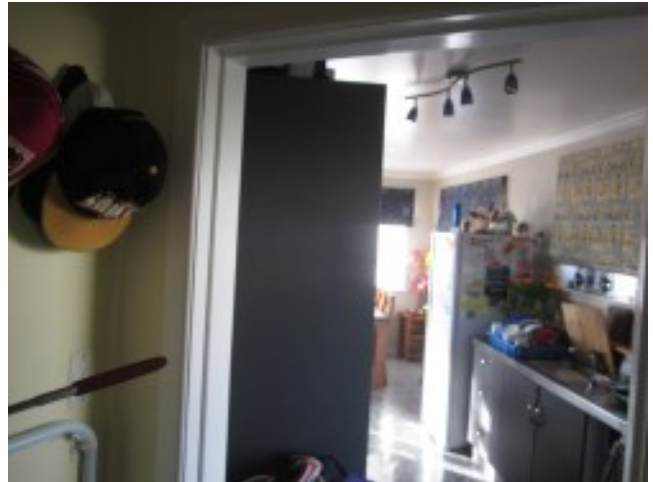
Recommend separate washing machine waste to tub area

No door noted to the laundry area

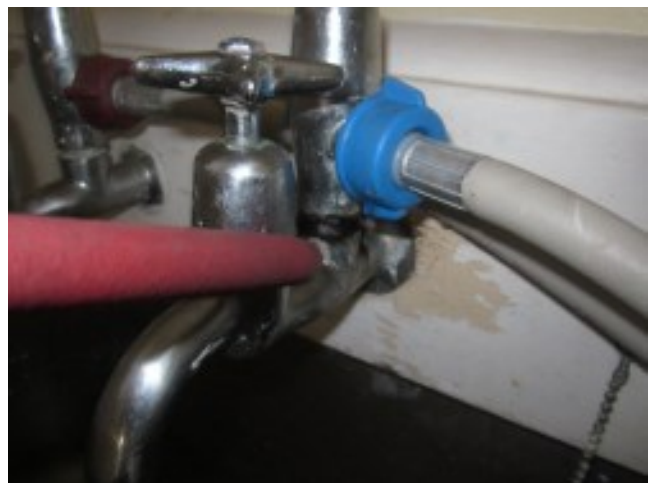
Waste pipes need supporting in the subfloor area

Tub tap is leaking, will need attention

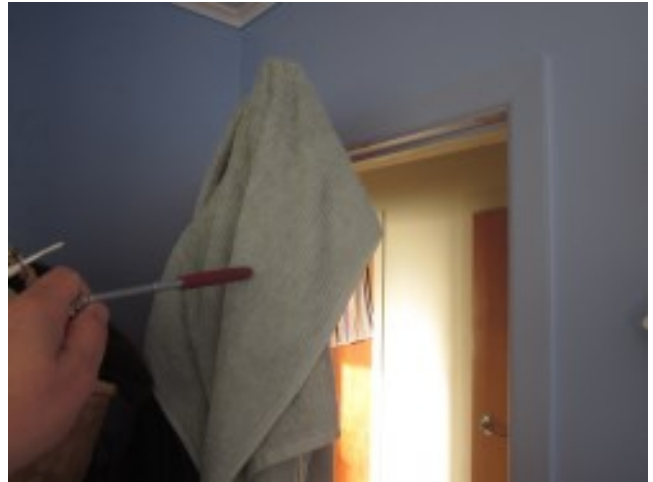
Bedroom one appears in reasonable condition

Door needs easing, minor maintenance

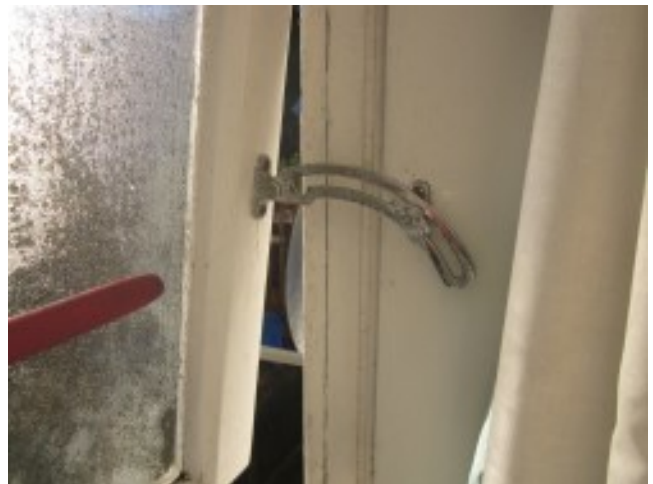
Moisture fluctuations to exterior walls appear normal

Window hardware needs attention to some windows

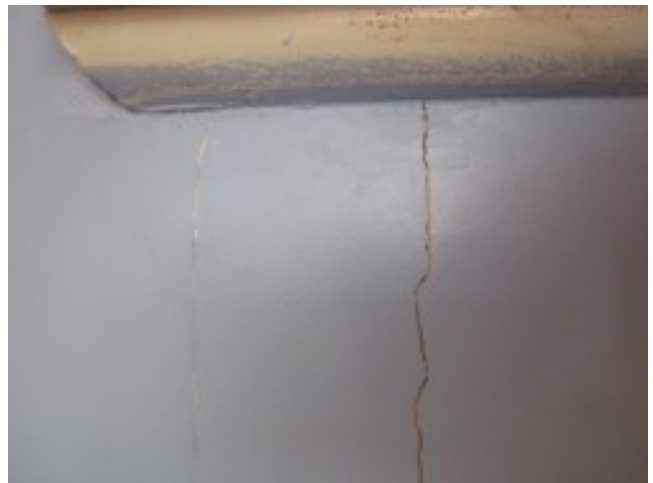
Paint wear noted to window frames, will need attention

Movement cracking noted, very common to most homes

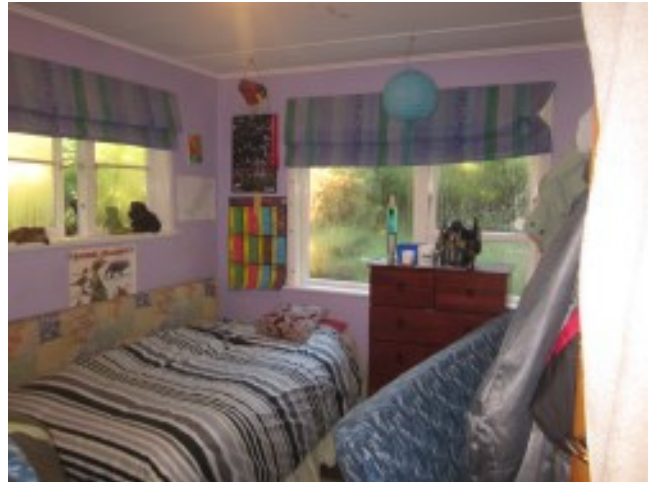
Paint wear noted to lower skirting s noted

Bedroom two appears in reasonable condition

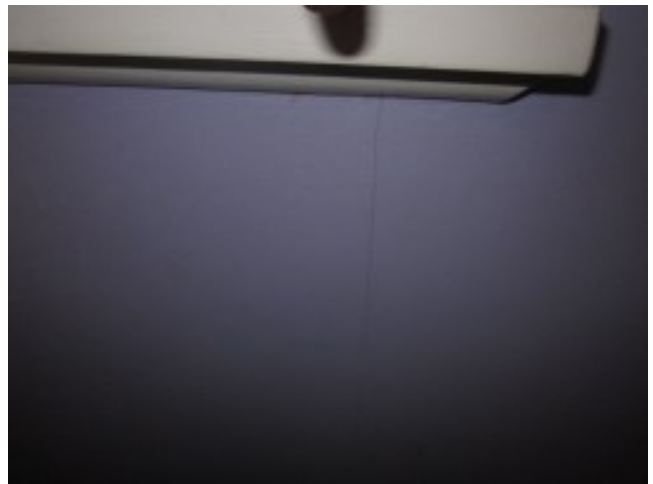
Moisture fluctuations to exterior walls appear normal

Movement cracking noted, very common to most homes

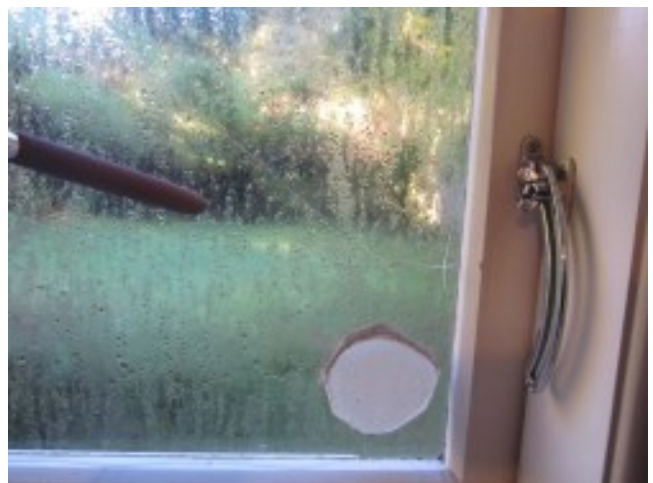
Heavy condensation noted to window frame

Cracked glass noted, will need attention

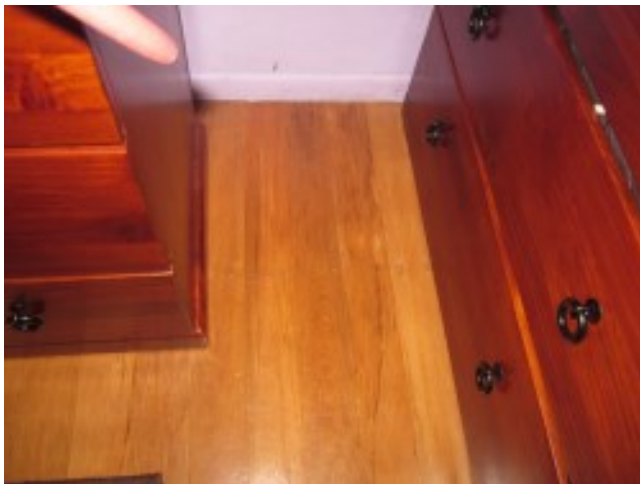
Patch noted to the ceiling area

Timber floor boards appear in good order

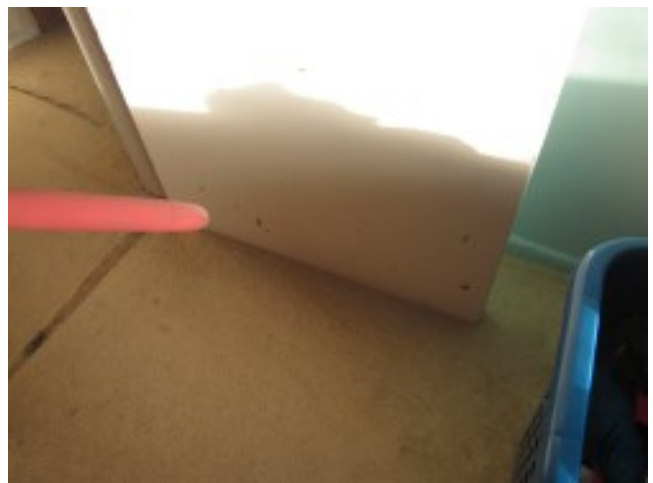
Recommend door stops to all internal doors

Door needs easing as sticking at the carpet

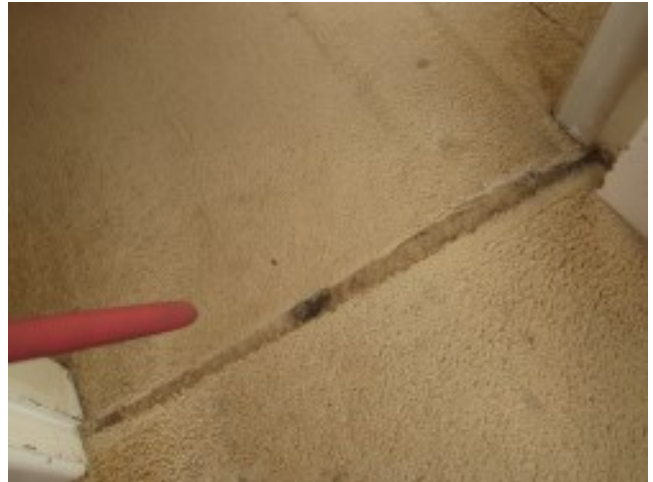
Paint wear noted, will need attention at some stage

Carpet shows heavy wear in areas, will need attention

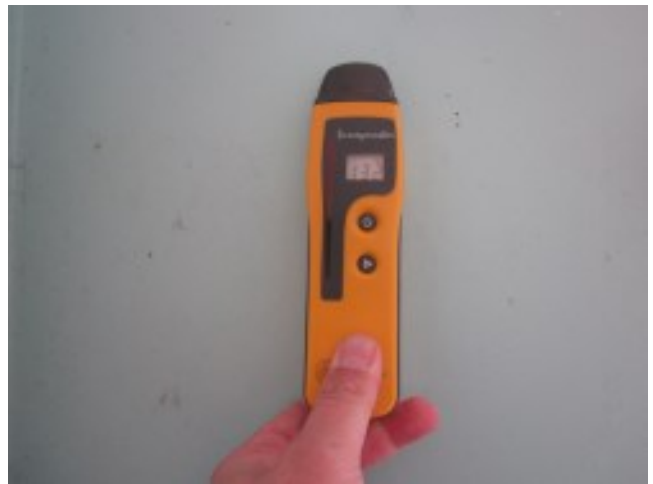
Windows needs easing minor maintenance

Moisture fluctuations to exterior walls appear normal

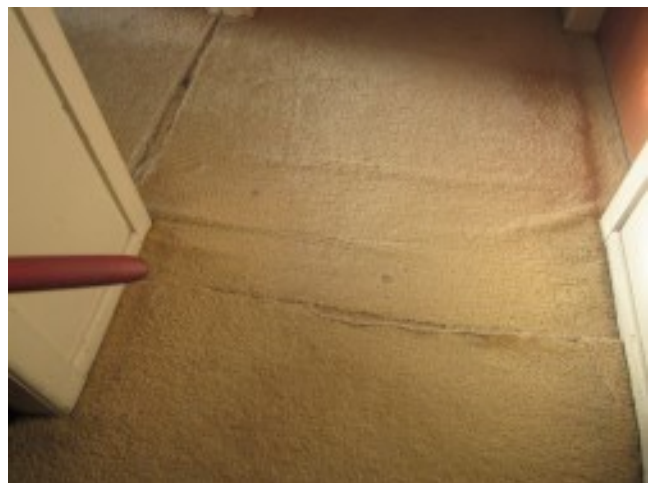
Hall way area appears in reasonable order

Carpet shows heavy wear in areas noted

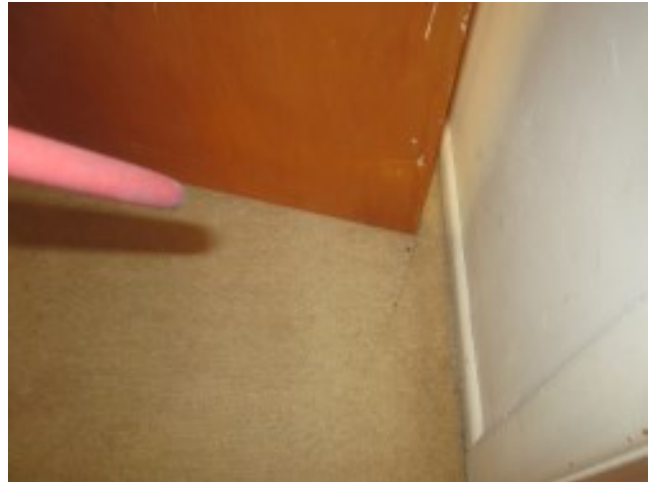
Door trim shows wear, will need attention

Door needs easing as is sticking at the carpet

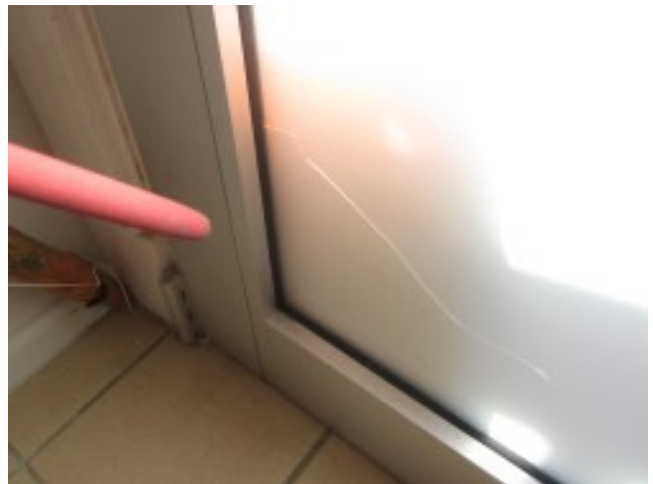
The lounge area appears in reasonable condition

Cracked glass to front door noted, will need attention

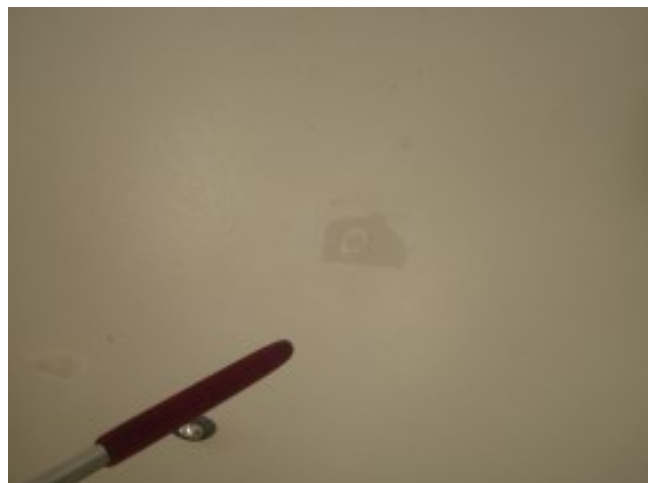
All beams appear well fixed in place and in good order

Minor wear to the ceiling area noted

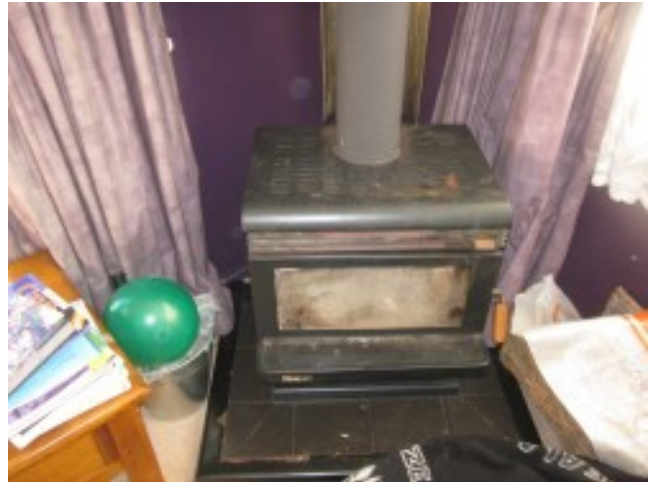
Movement cracking noted, very common to most homes

Wood burner noted appears in reasonable condition

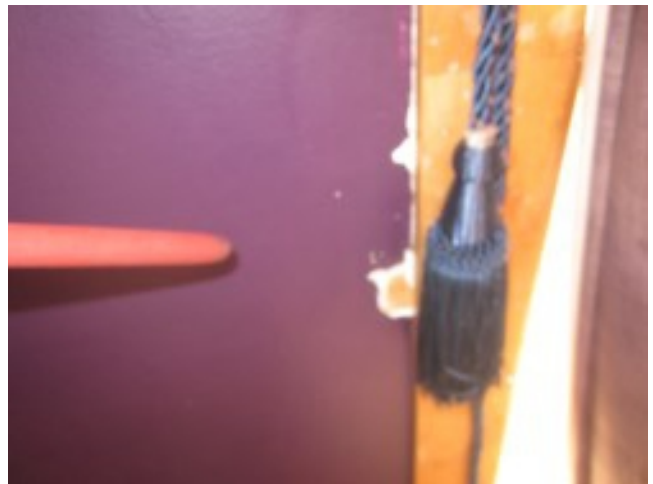
Moisture fluctuations to exterior walls appear normal

Paint wear noted to areas, will need attention at some stage

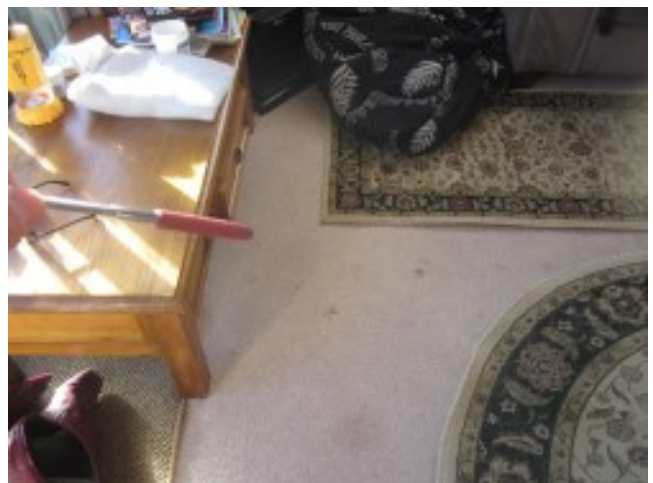
Movement cracking noted, very common to most homes

Carpet shows staining in areas noted

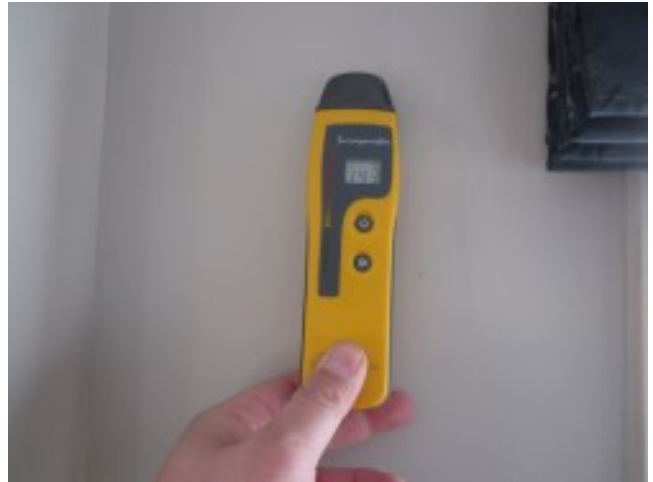
Dining room area appears in reasonable condition

Moisture fluctuations to exterior walls appear normal

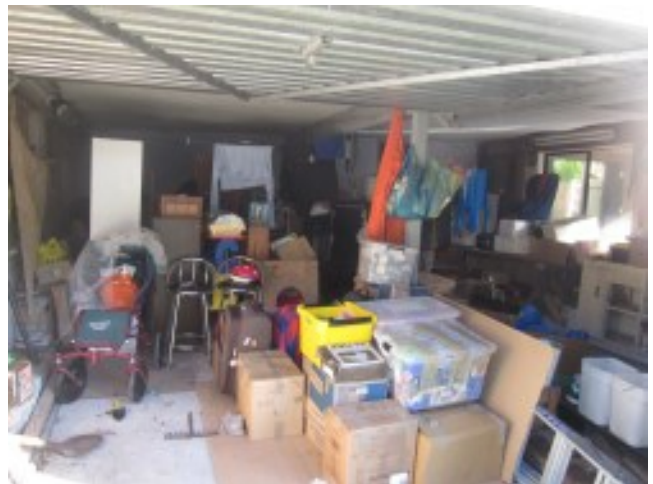
Movement cracking noted, very common to most homes

Double garage area noted appears in average condition

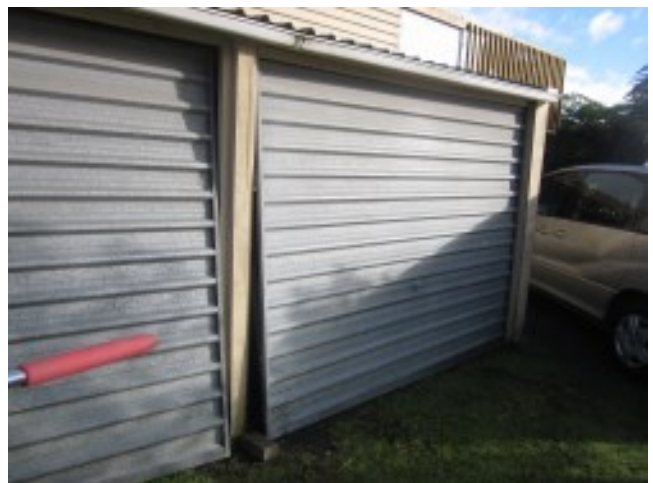
Wrong sized framing used to garage area, will need attention

Garage framing has twisted, will need attention
