Home Inspection Report

Property Located At
10 Moana Grove
Tawa, Wellington
New Zealand

Inspection Date: 24th June 2013
Inspected By: Mark Sewell
Report No.: RPT118

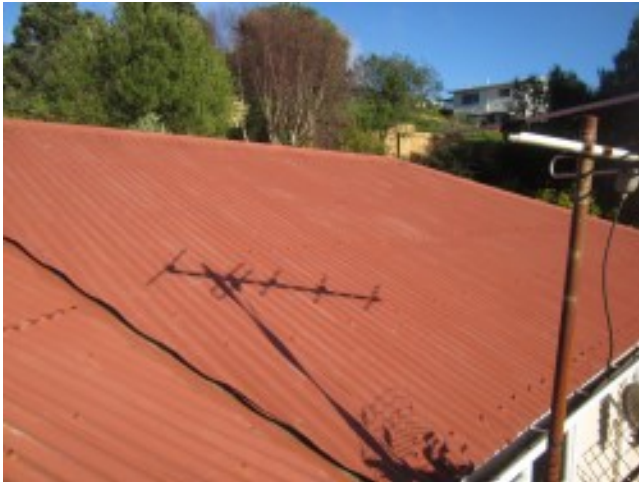
The roof does appear in reasonable overall condition

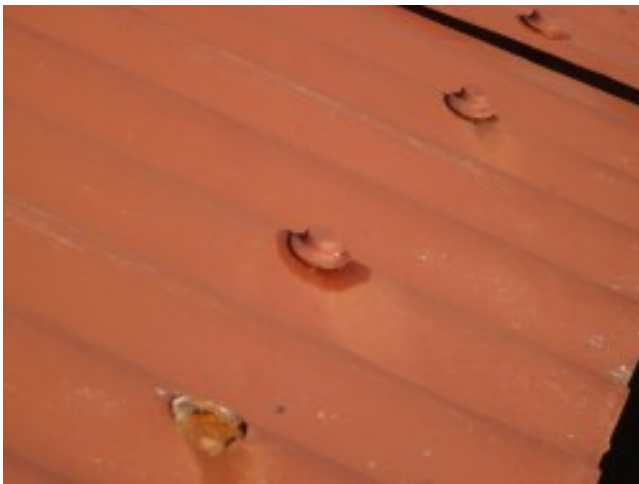
Lead heads have come away in areas and will need attention

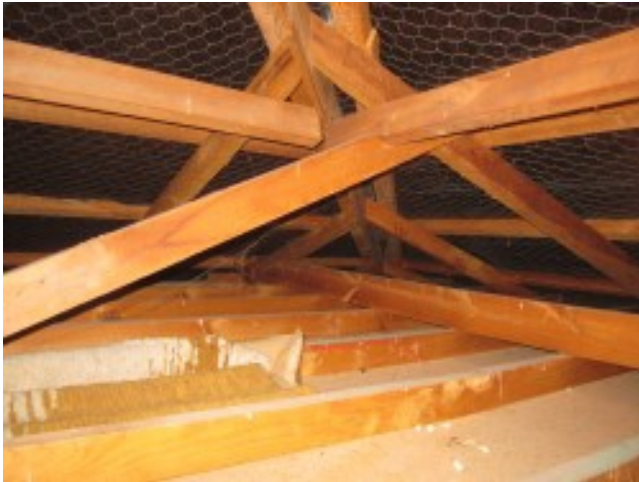
The odd roof fixing is leaking and will need attention

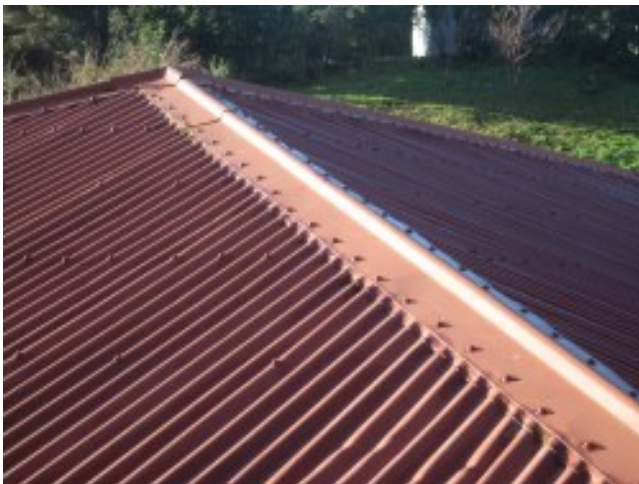
The ridge flashings appear in reasonable condition

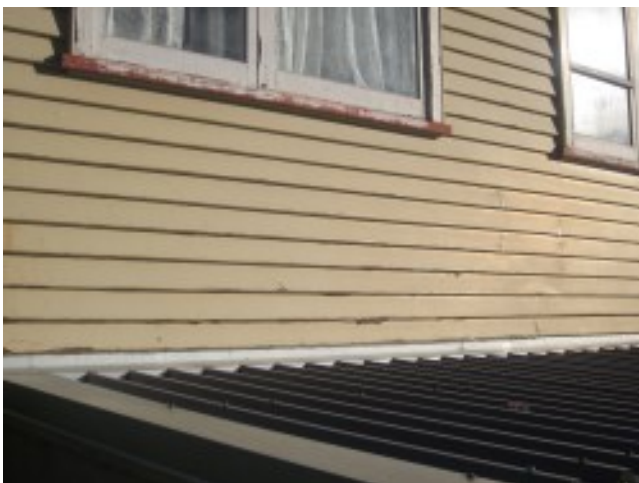
The roof and cladding junction appears well detailed

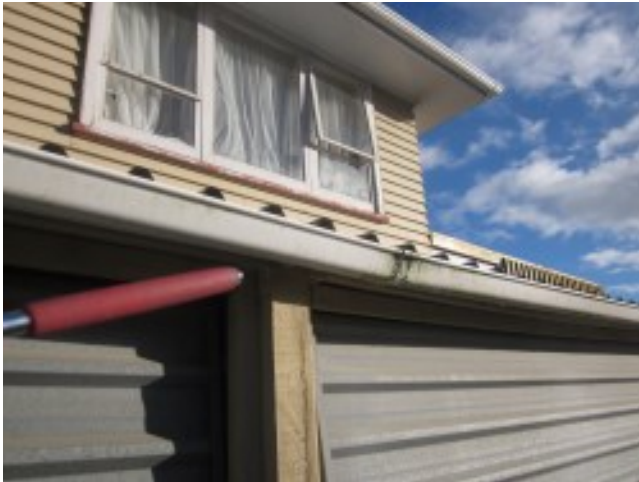
Lower spouting to the garage area is leaking and will need attention

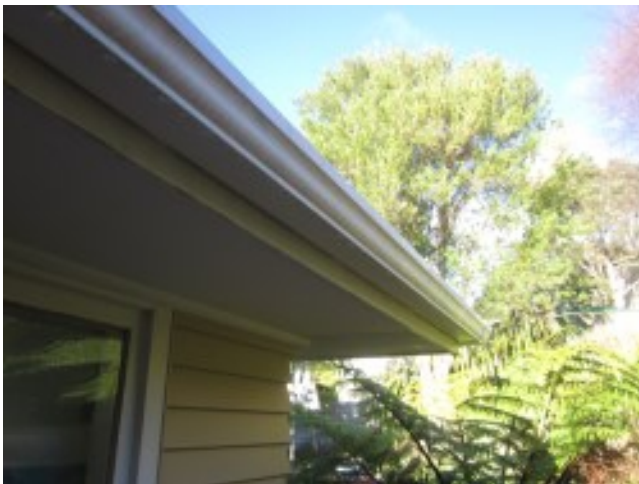
The spouting appears in good overall condition

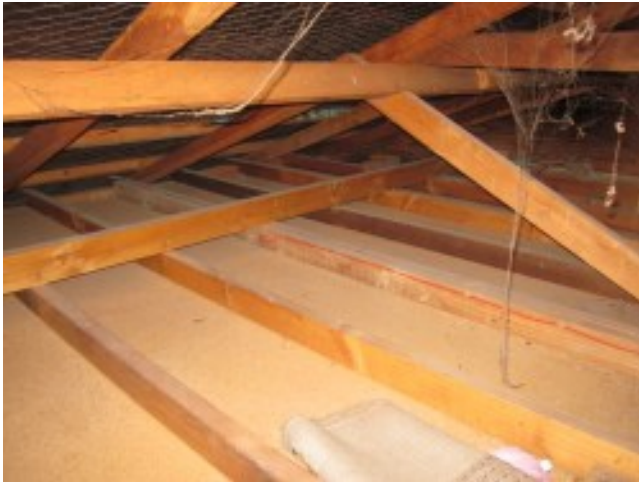
No insulation to the ceiling space noted, but recommended

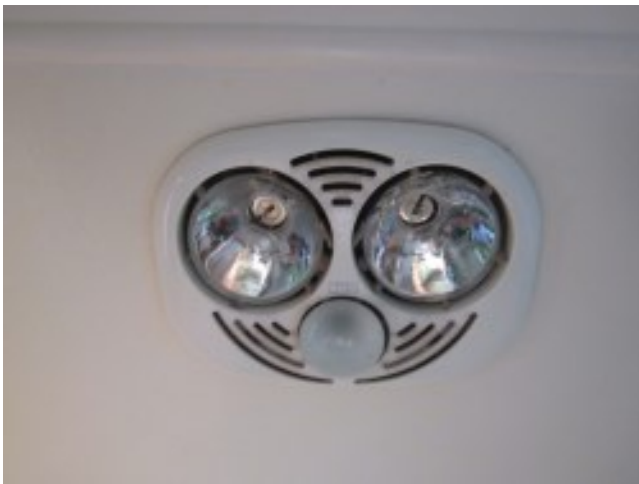
Bathroom fan needs venting to the exterior noted

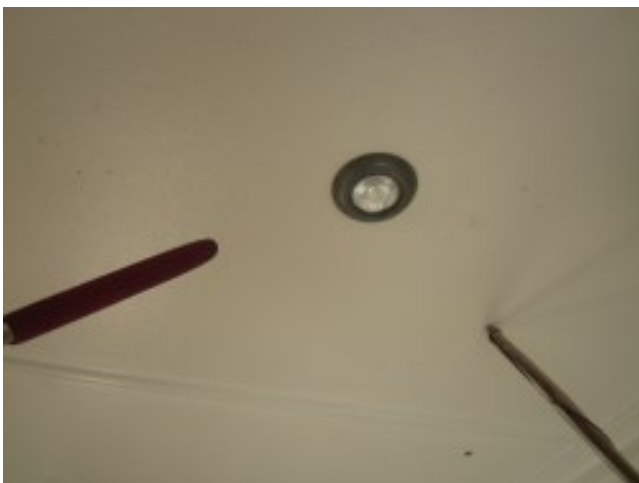
Recessed light fittings appear in good order

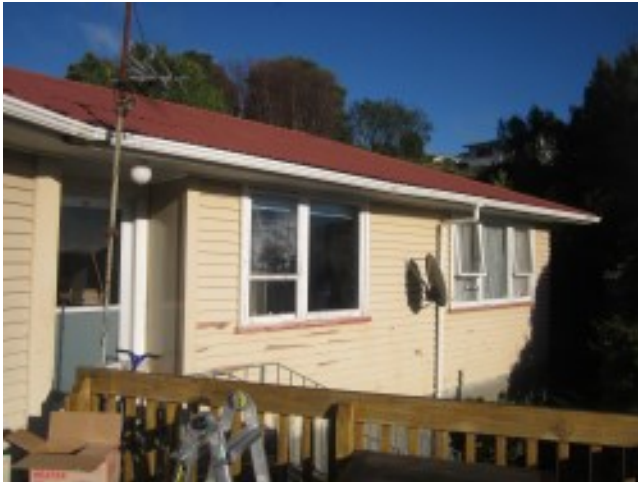
The exterior cladding requires maintenance in many areas noted

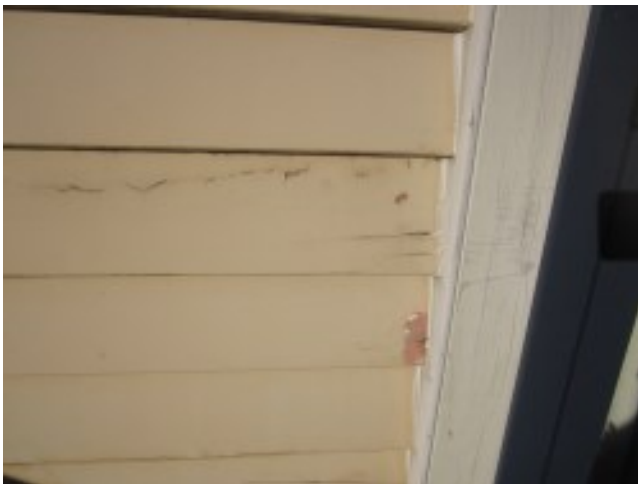
The odd window and cladding junction needs re-sealing

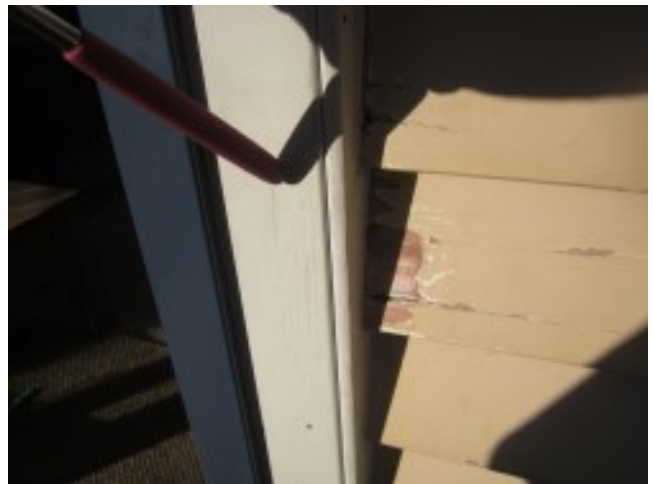
Many cladding junctions need re-sealing and re-painting

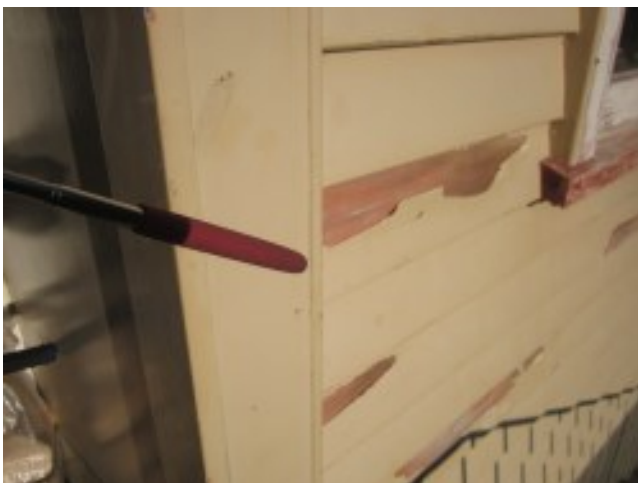
The exterior needs sanding back and re-painting

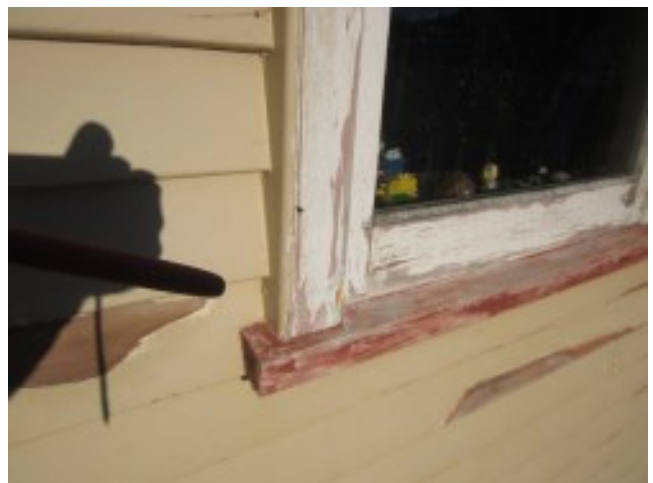
All exterior window frames require maintenance and re-painting

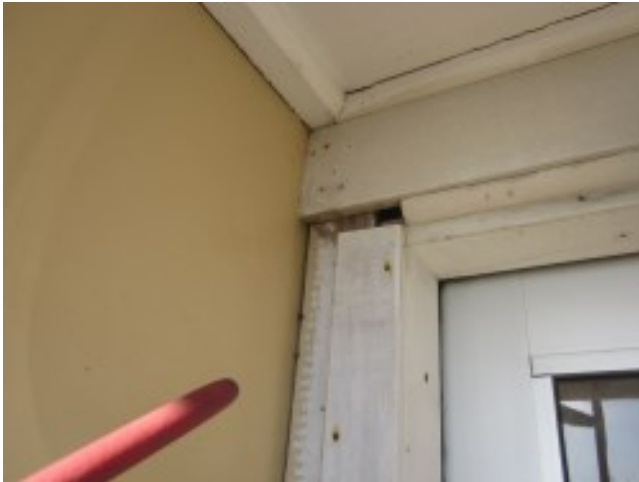
Trim around front door is poorly finished, needs attention

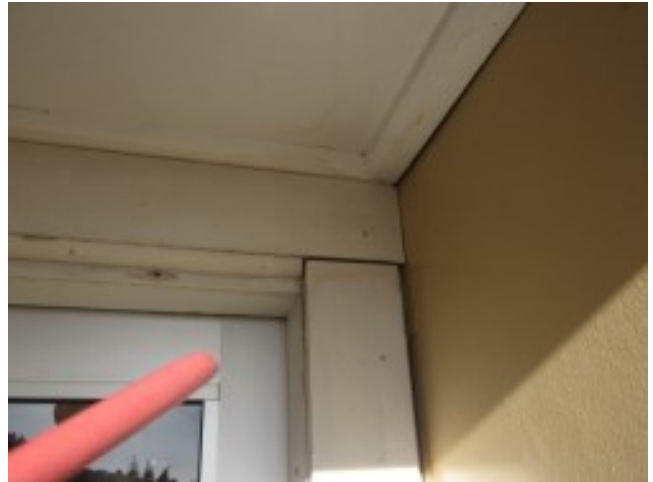
Trim is poorly sealed and will need attention

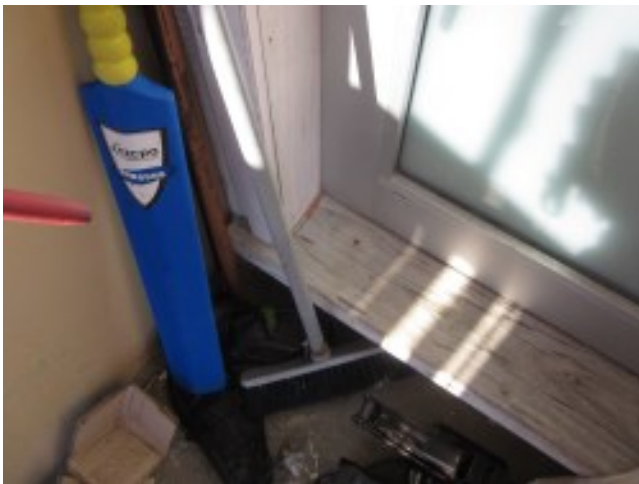
Lower door sill needs re-painting

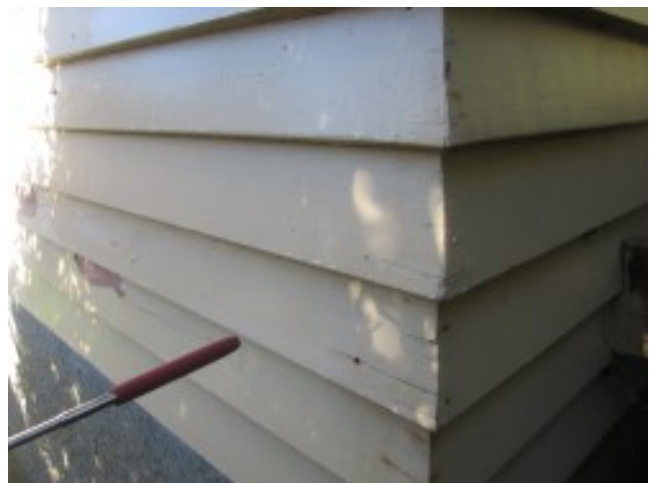
External weather board junctions need re-sealing

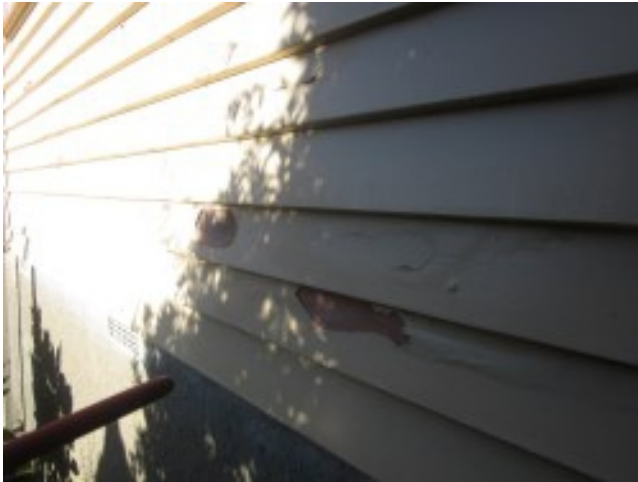
Paint has come away in many areas, will need attention

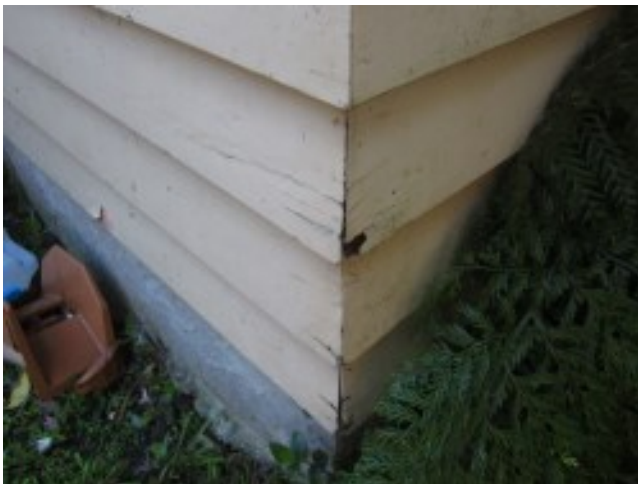
Rot noted to some weather boards will need attention

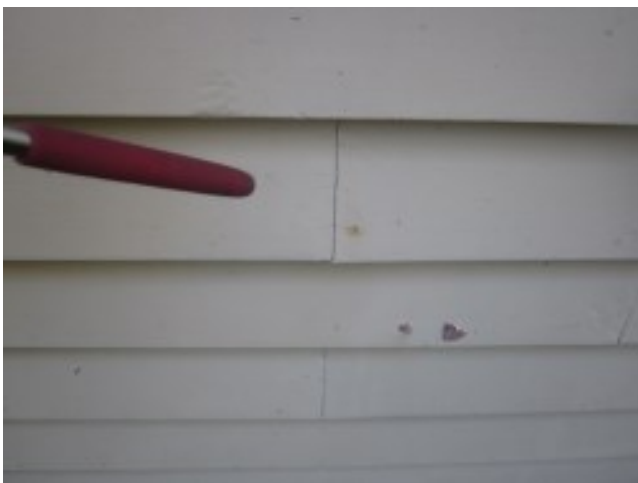
Many weather board junctions need re-sealing noted

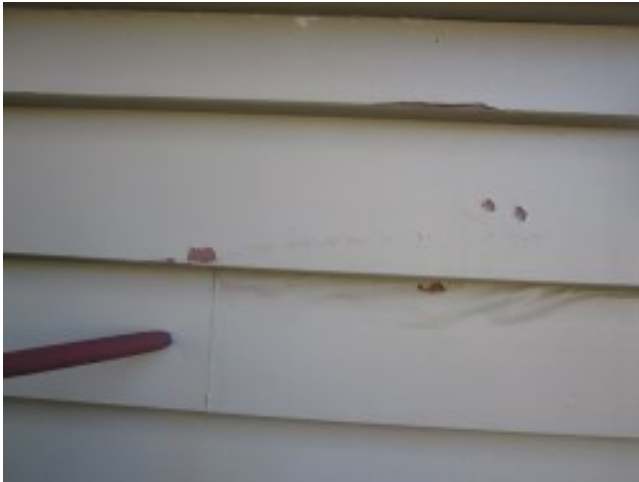
Paint wear to many areas of cladding noted, will need attention

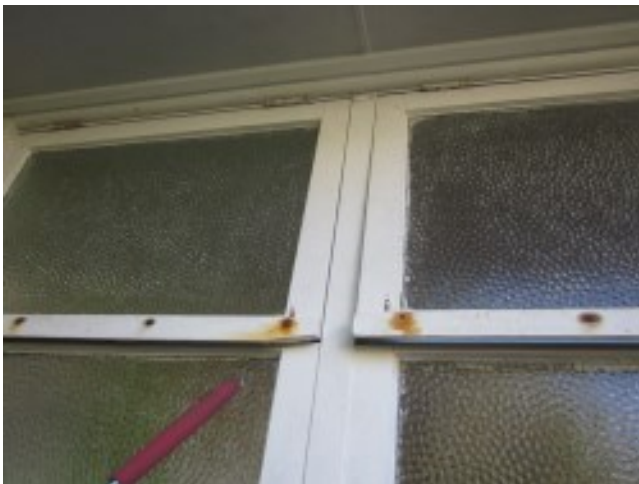
Rusted fixings noted to many windows, will need attention

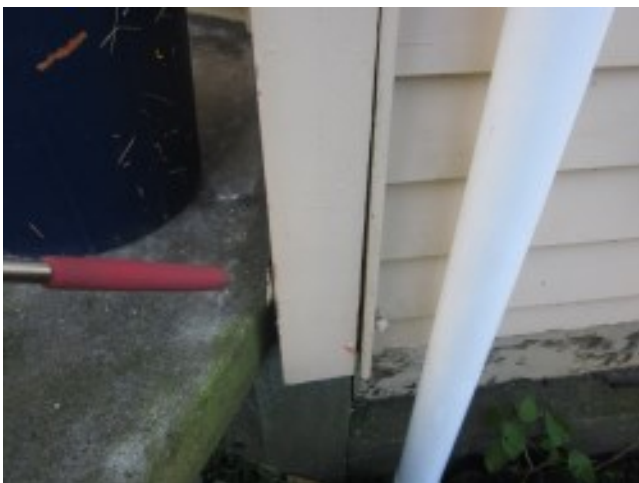
Timber trim needs re-sealing in areas noted

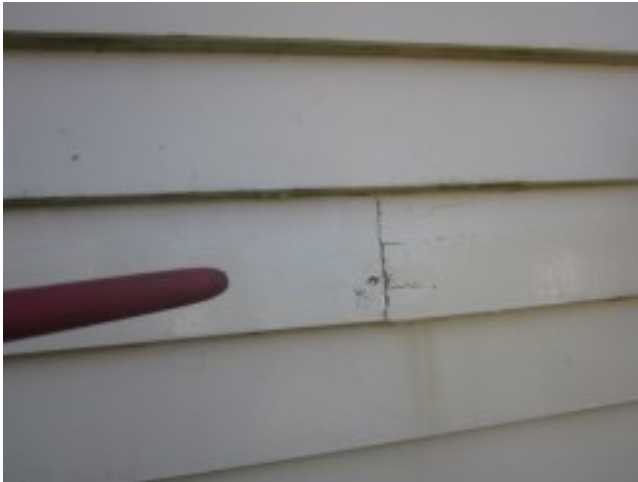
Weather board junctions need re-sealing in many areas

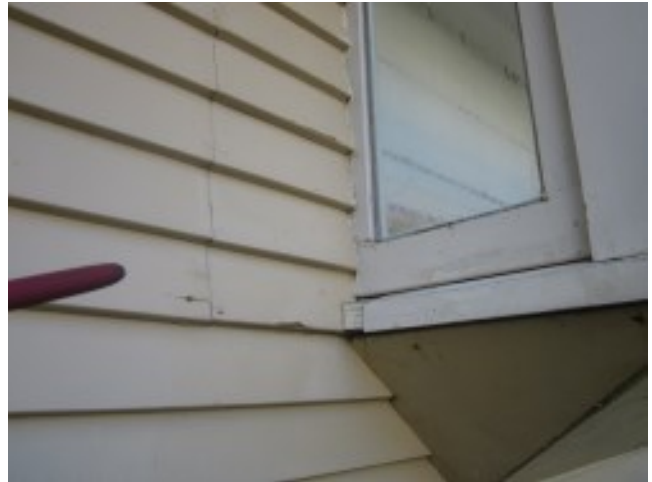
Weather board junctions need re-sealing at this junction

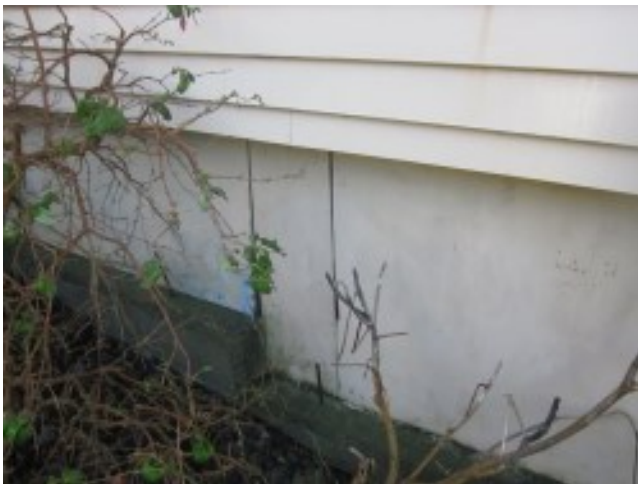
Lower base cladding appears in reasonable order

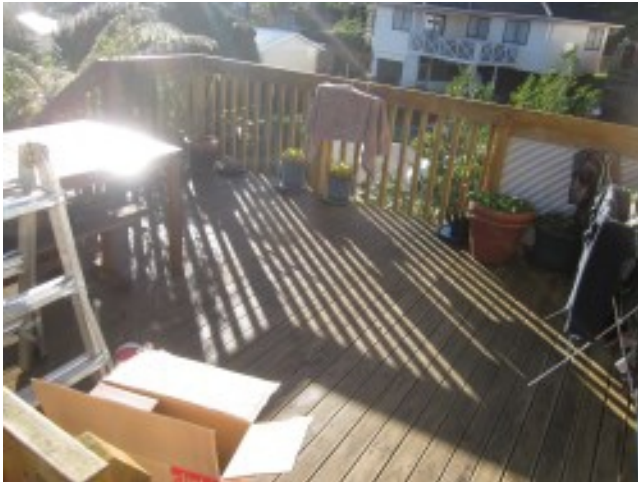
The timber deck area appears in good order

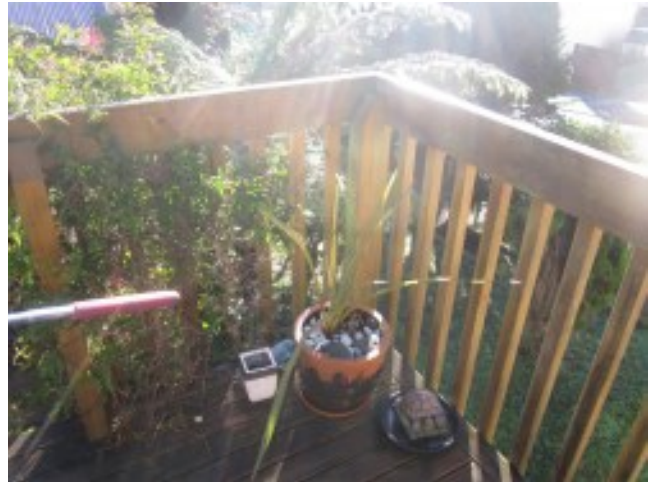
The deck rail is well fixed in place and in good order

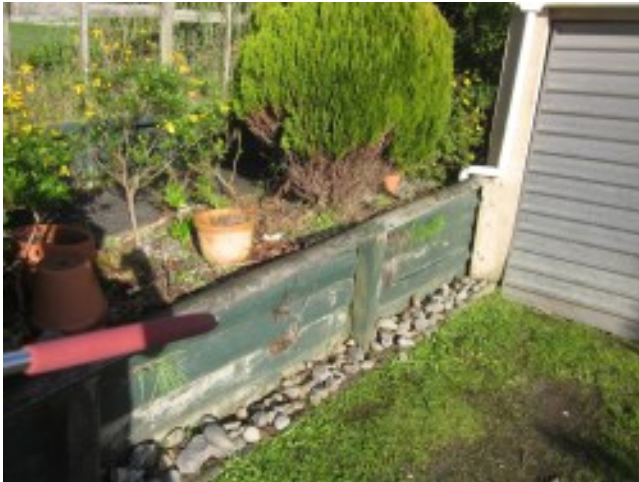
Lower retaining wall shows seepage, will need attention

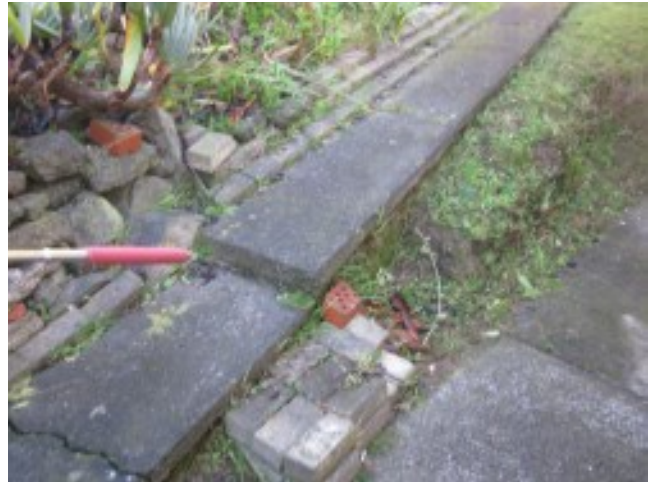
Bank will need retaining under rear footpath area

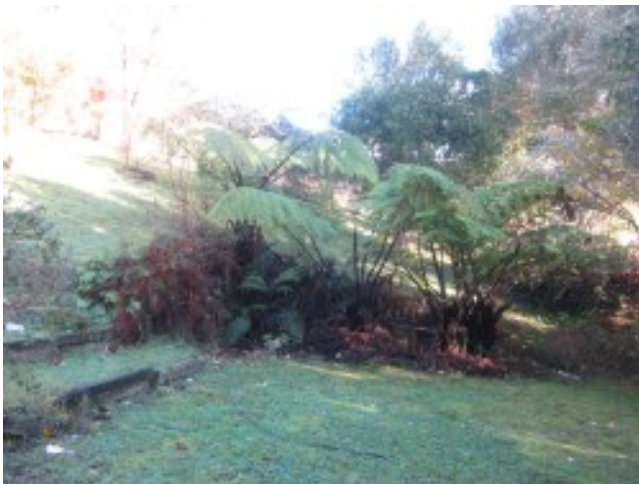
The grounds appear well developed and well maintained

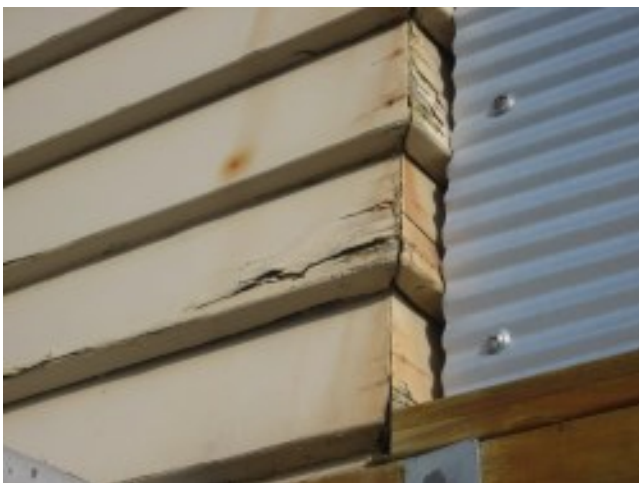
Exterior cladding junctions need attention in many areas noted

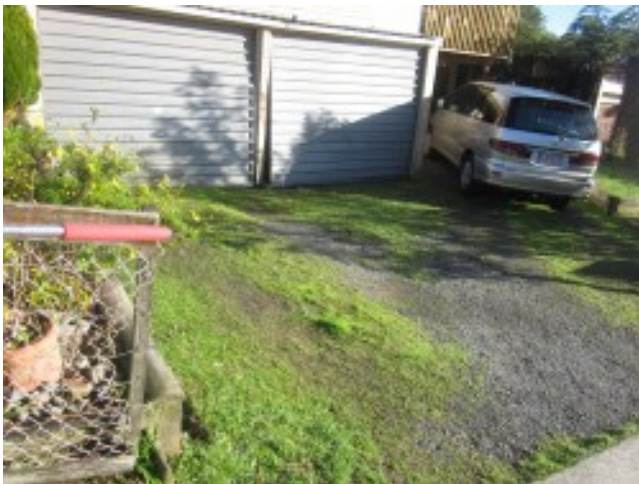
Gravel drive way area noted, appears in reasonable order

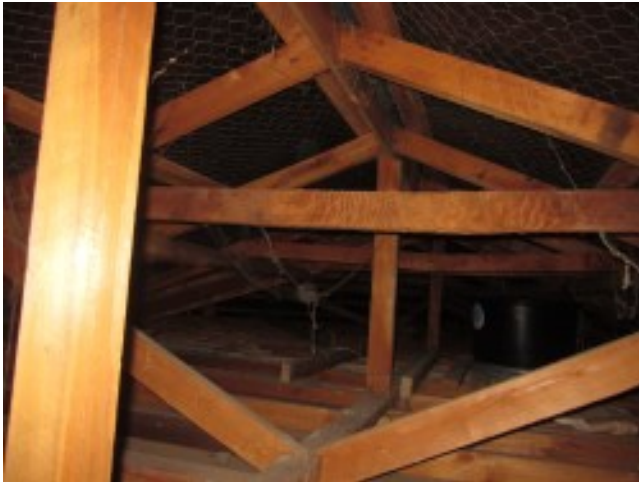
The roof framing appears dry and is in good order

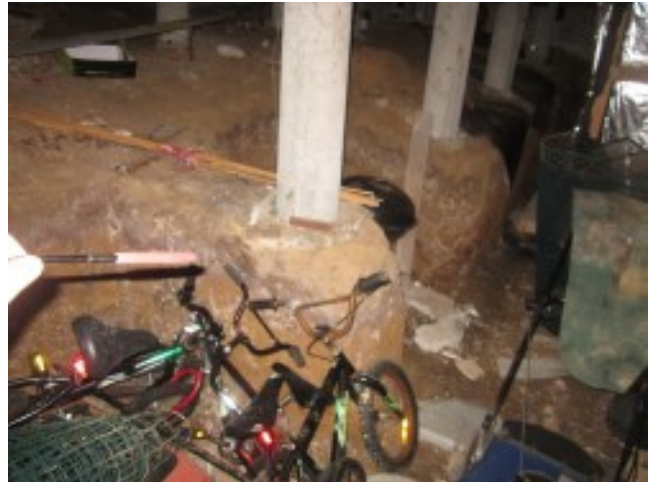
Checkpoint	Rating	Action	Comment
Footings	U	I	The footing has been under mined in areas and will need attention
Foundation	U	C	The concrete piles and foundation wall have been under mined in areas and will need, re-supporting. This is not ideal as in an earthquake these piles could fail.
Sills	F	I	All appear in average order and will need attention
Beams	S	N	Beams appear well fixed in place and are in good condition
Joists	S	N	Bearers and floor joists are in good condition
Sub Floor	F	I	The subfloor area appears dry and in reasonable order, the foundations need attention in areas noted
Floors	S	N	All floors appear in good overall condition
Walls	S	N	All walls appear straight and in good order, the cladding does require maintenance in areas noted
Roofs	S	N	The roof framing appears dry and in good condition
Chimneys	S	N	The chimney appears in good order
Lintels	S	N	Unable to sight
Vermin / Insects	N	N

Concrete piles have been under mined, will need attention

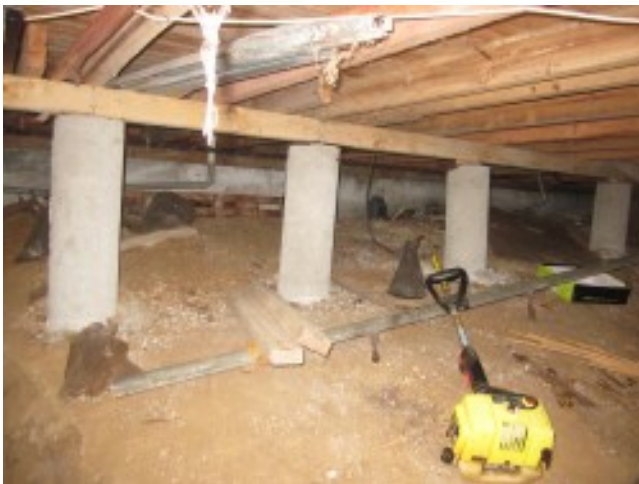
Central row of piles appear in good condition

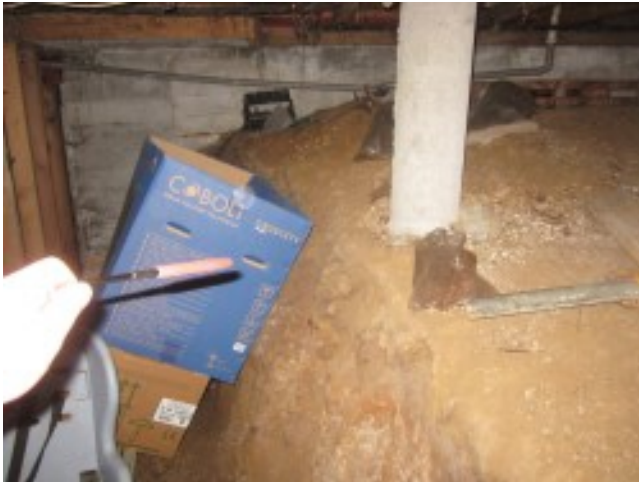
Bank has been cut to close to lower pile, will need attention

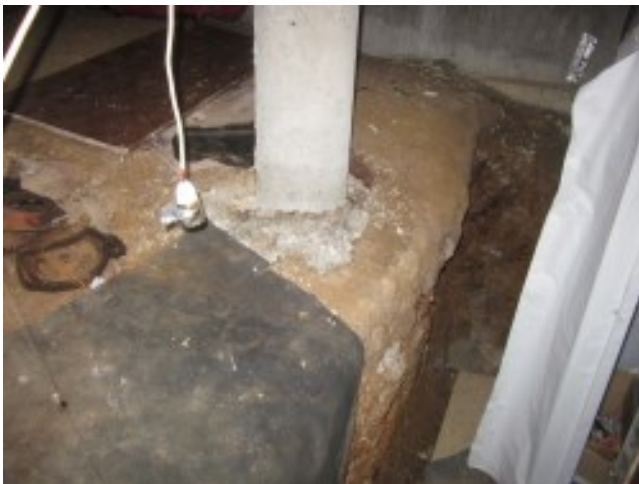
Ground level has been dug away from lower pile, will need attention

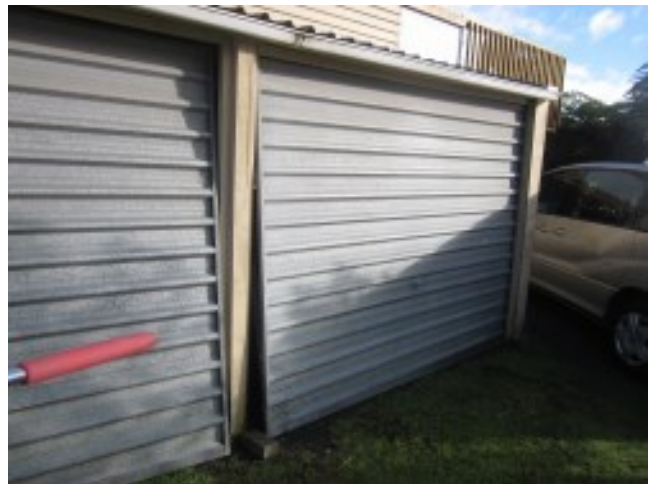
Framing to front of garage requires re-work

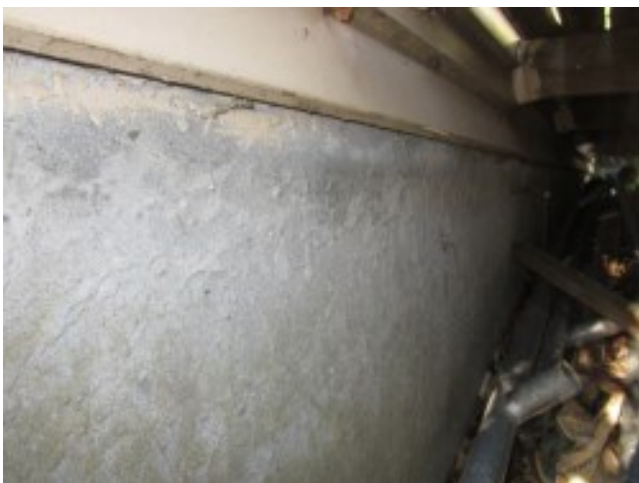
Exterior concrete ring foundation appears in good order

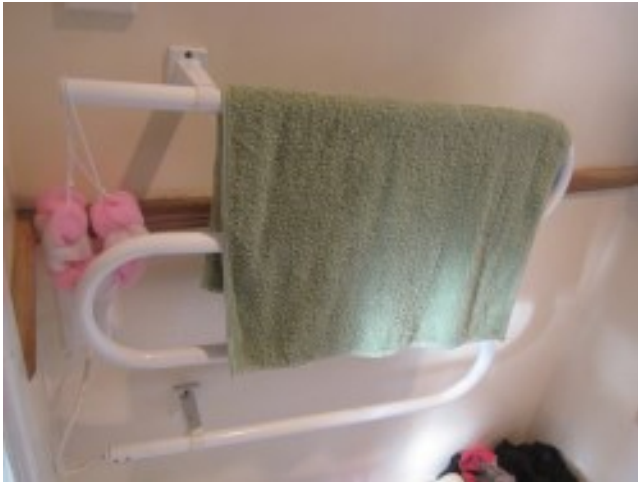
Heated towel rail appears in reasonable condition

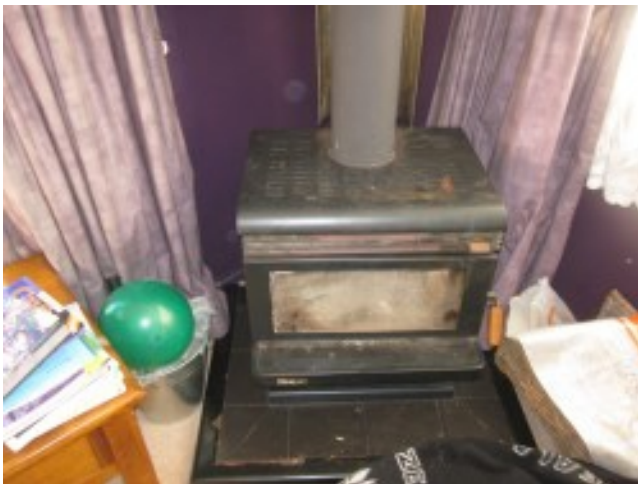
Wood burner noted appears in reasonable condition

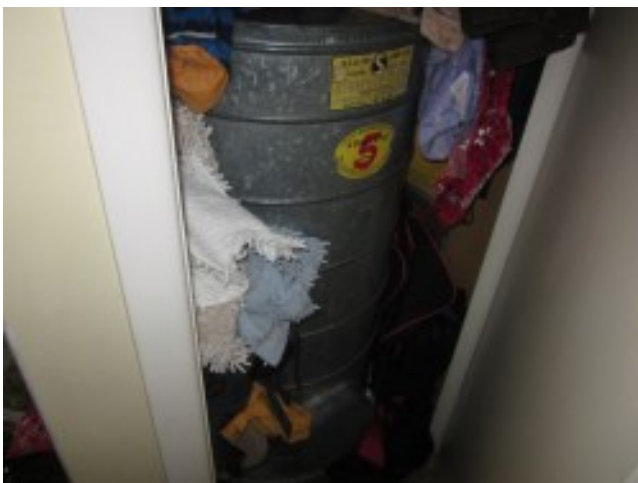
Checkpoint	Rating	Action	Comment
Gas Meter	NA	N	
Gas Piping	NA	N	†
Clearances	NA	N	†
Boiler	NA	N	†
Electric Heating	U	R	Older type low pressure hot water cylinder noted, the unit is leaking and will need up grading.
Radiators	NA	N	
Underfloor Heating	NA	N	
Heat Pump	NA	N	†
Gas Wall Heater	NA	N	
Gas Walled Heater Flued	NA	N	
Gas Imitation Open Flame	NA	N	†
Electric Wall Heater	F	I	Heated towel rails noted, does require maintenance
Wood Burner	S	N	The wood burner appears in reasonable condition, but recommend having the unit checked and cleaned before use
Gas Central Heating	NA	N	†

Older low pressure hot water cylinder is leaking, needs attention

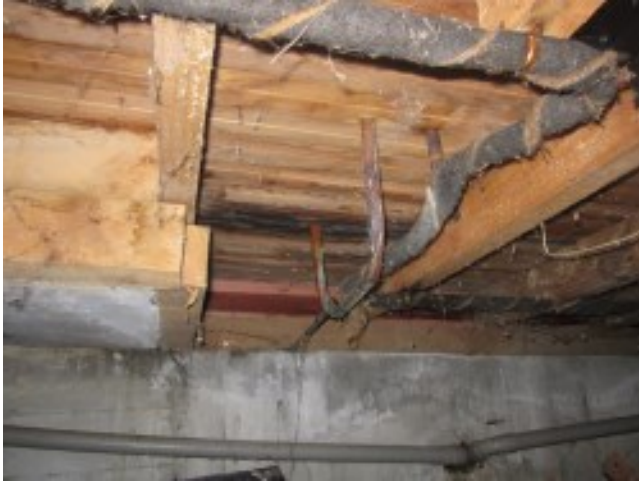
Cylinder is leaking into the subfloor area, will need replacing

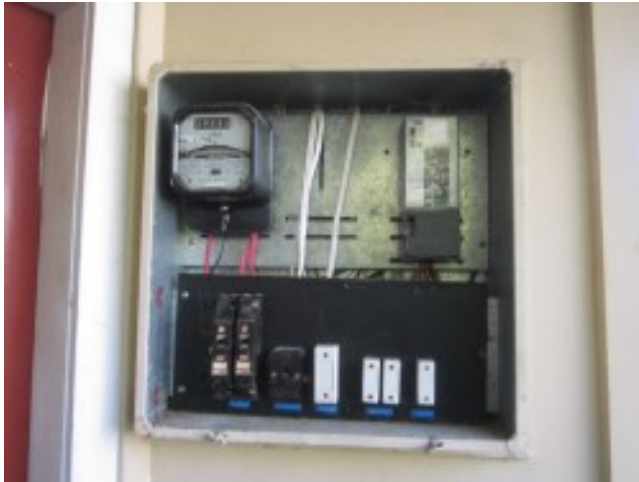
Meter and switch board appears in reasonable condition

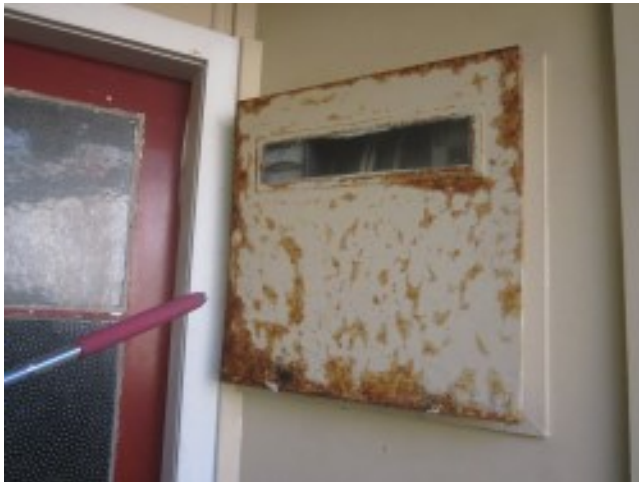
Meter cover shows rust, will need attention

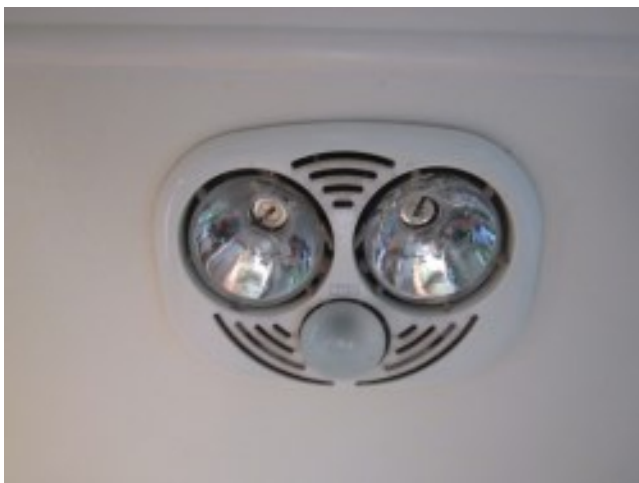
Bathroom fan appears in good working order

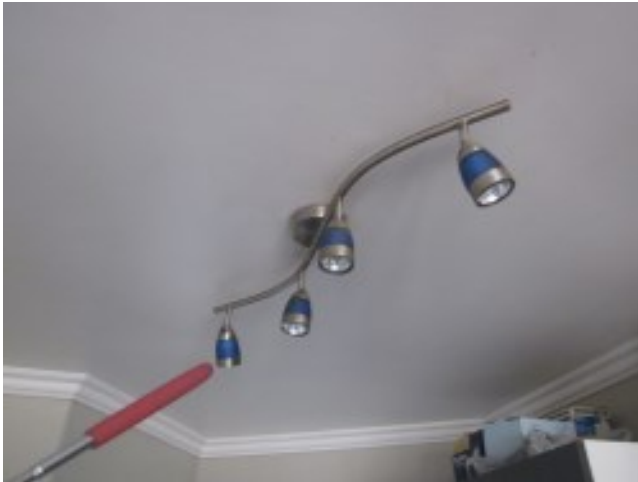
Interior light fittings appear in reasonable condition

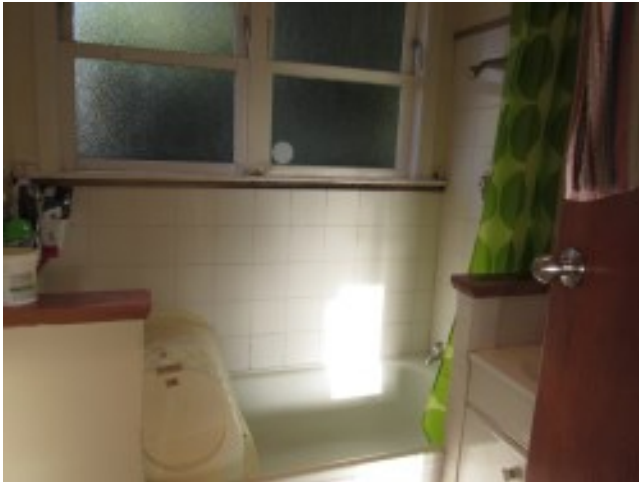
The bathroom area appears in reasonable order

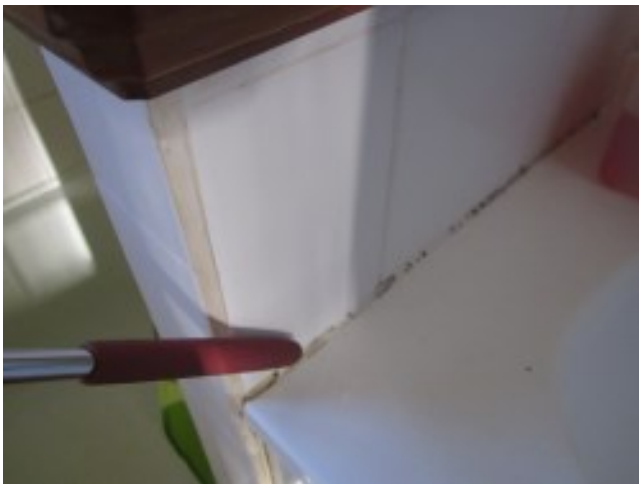
Mould noted to silicone, will need attention

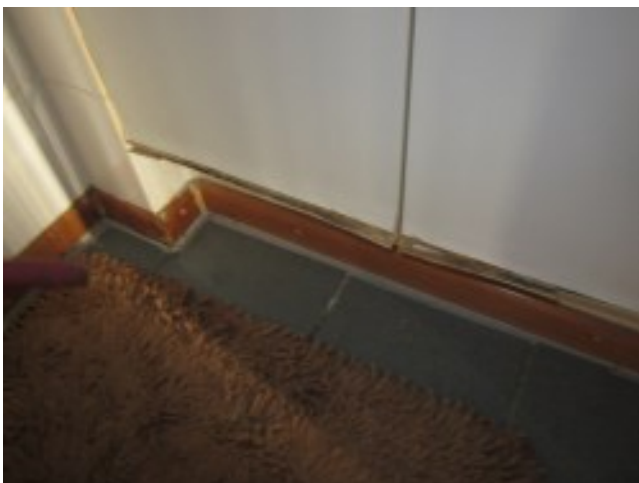
Lower vanity shows water damage noted

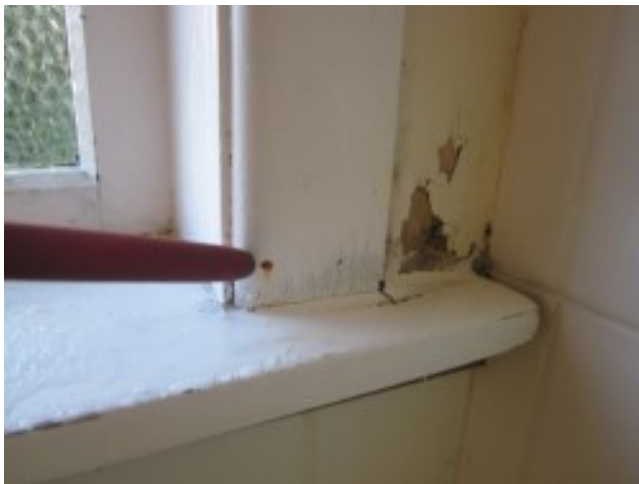
Moisture damage to window frame and wall, needs attention

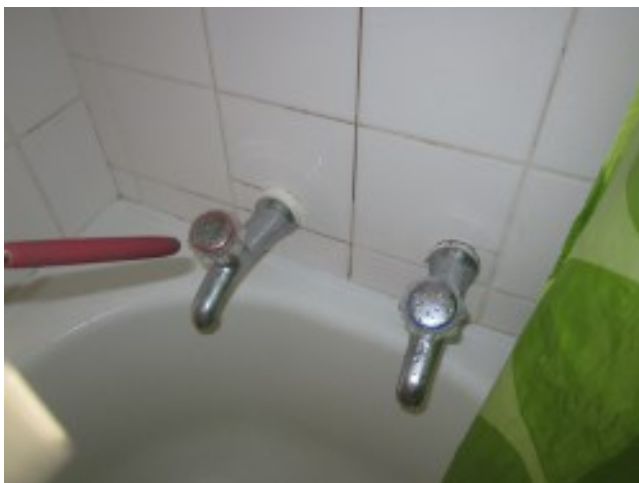
Bath taps are poorly sealed at the wall junction, needs attention

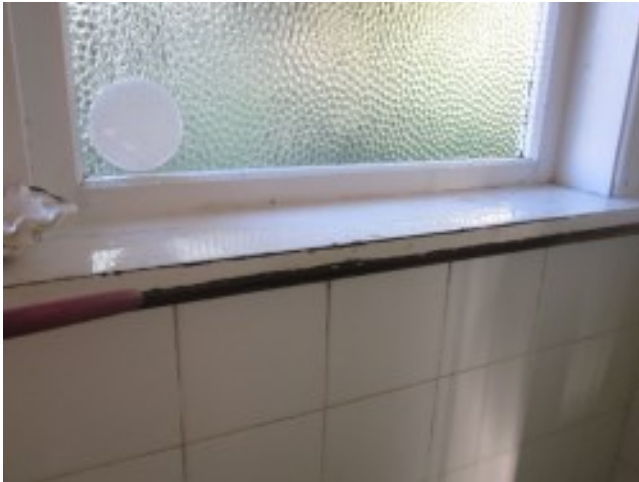
Window sill should be protected, when shower is in use

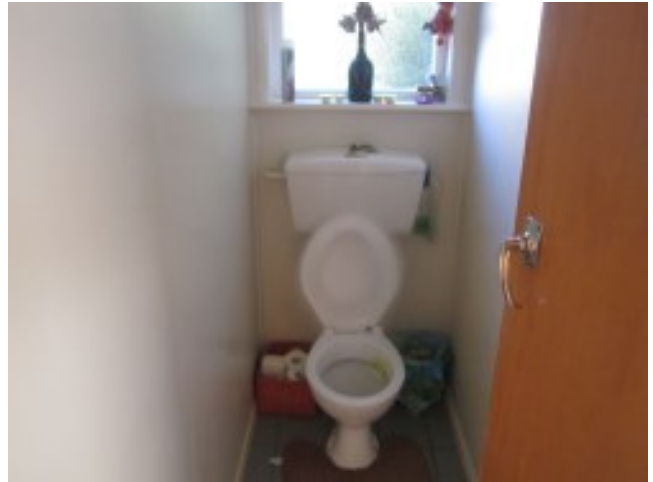
The toilet area appears in reasonable order

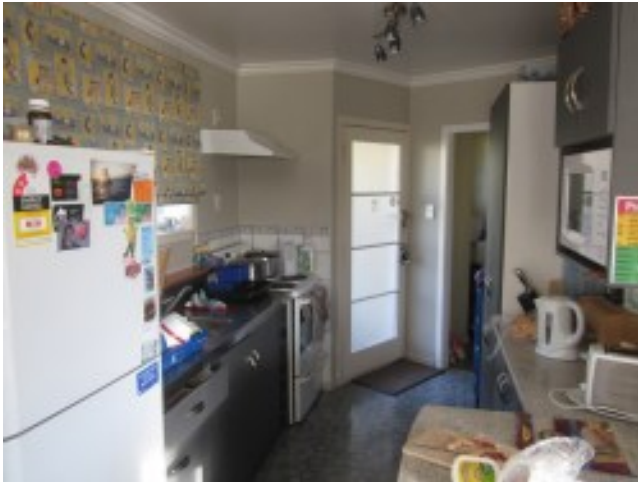
The kitchen appears is reasonable condition

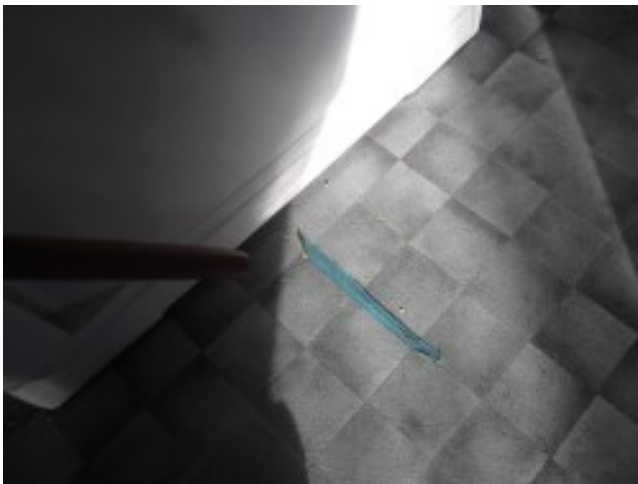
Wear noted to the vinyl in areas

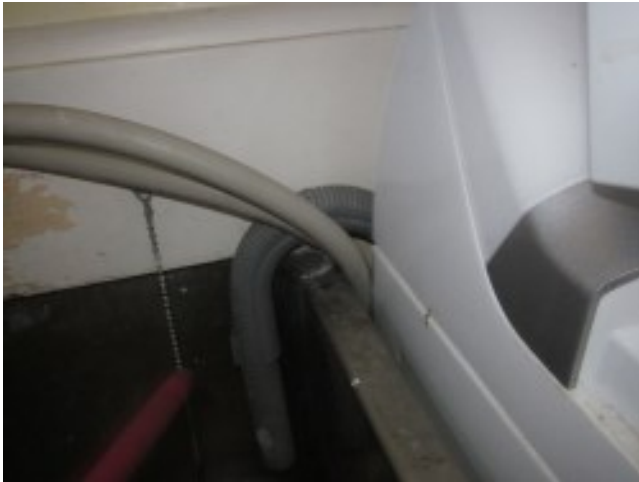
Recommend separate washing machine waste to tub area

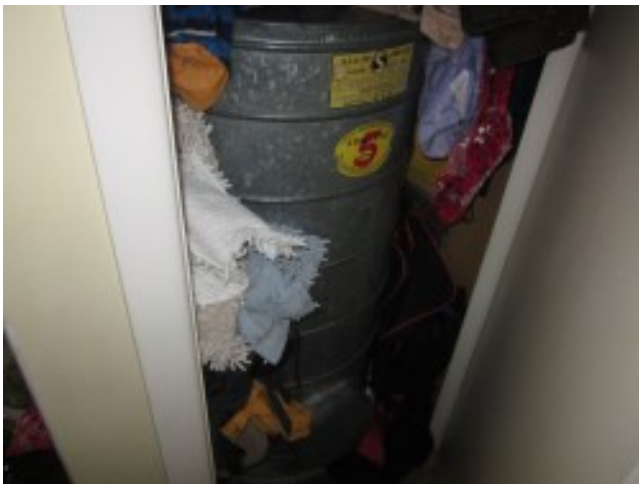
Older hot water cylinder is leaking, will need up grading

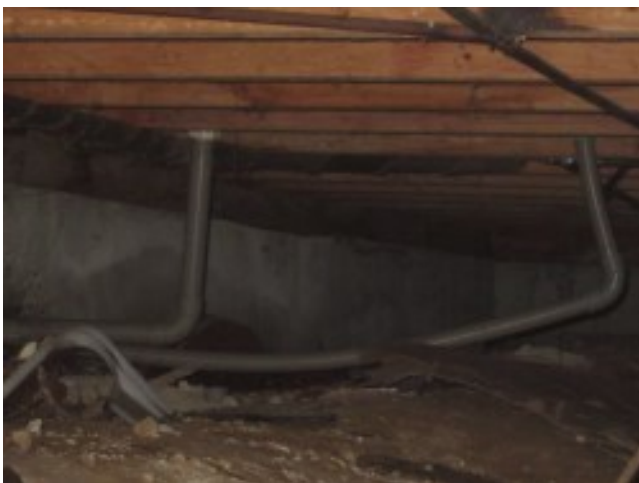
Waste pipes need supporting in the subfloor area

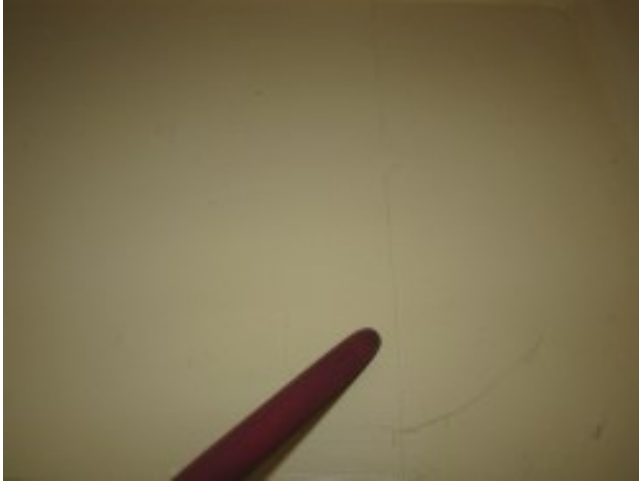
Movement cracking noted, very common to most homes

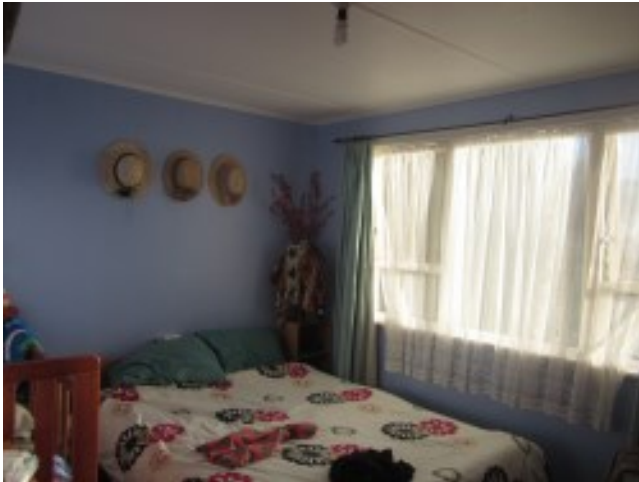
Bedroom one appears in reasonable condition

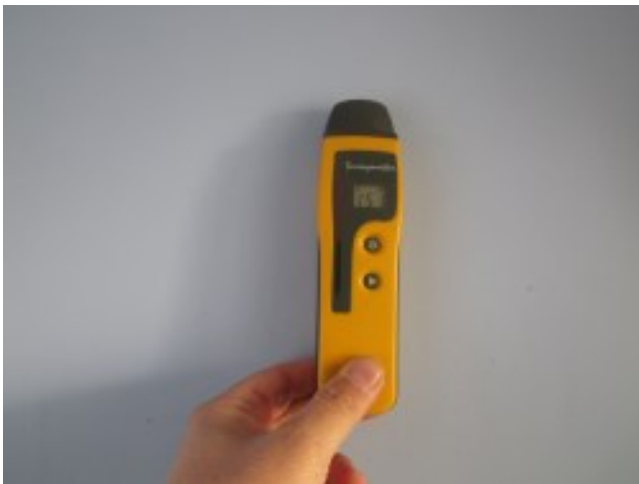
Moisture fluctuations to exterior walls appear normal

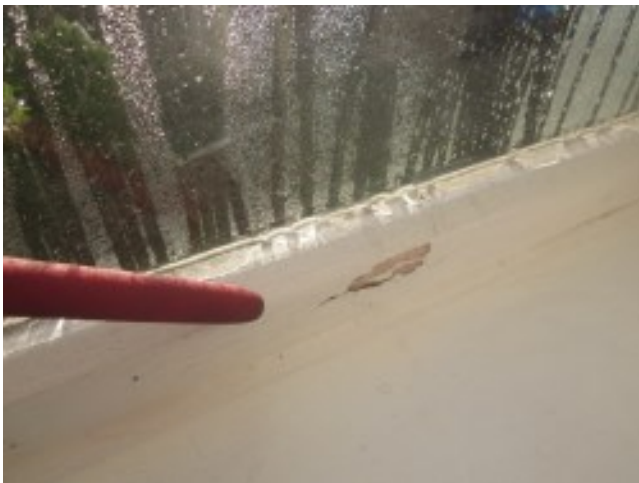
Paint wear noted to window frames, will need attention

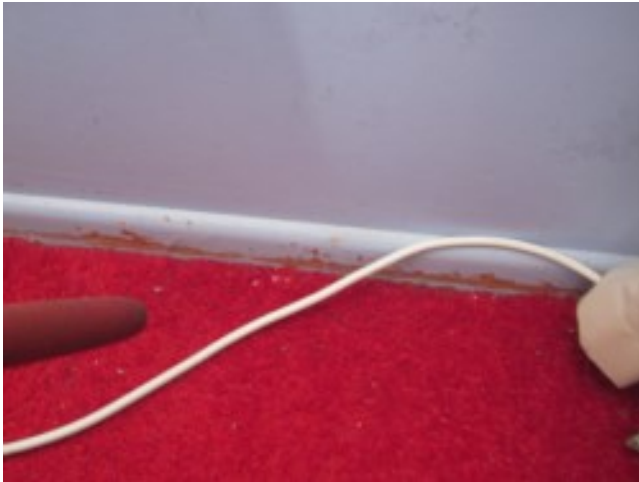
Paint wear noted to lower skirting s noted

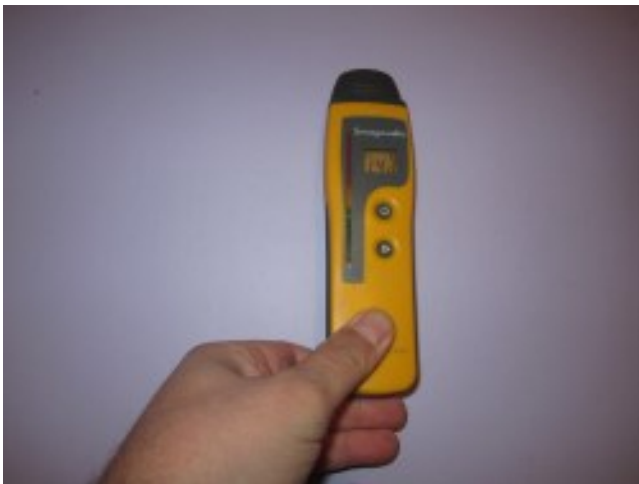
Moisture fluctuations to exterior walls appear normal

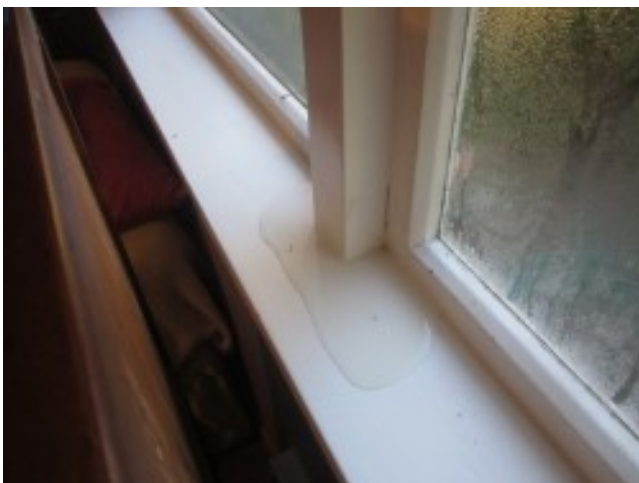
Heavy condensation noted to window frame

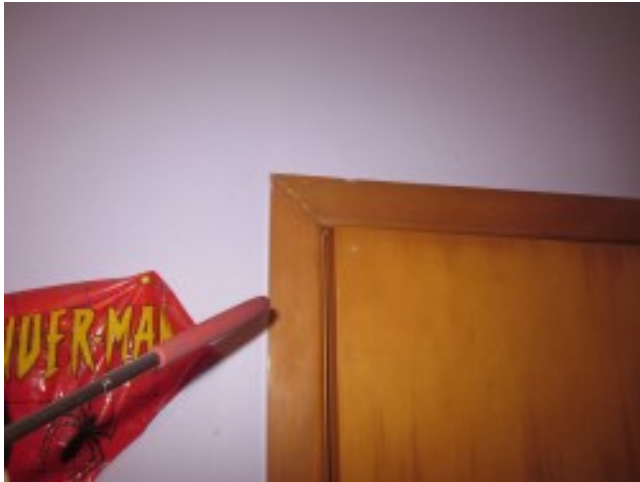
Wardrobe door needs easing noted
