Home Inspection Report

Property Located At
10 Moana Grove
Tawa, Wellington
New Zealand

Inspection Date: 24th June 2013
Inspected By: Mark Sewell
Report No.: RPT118

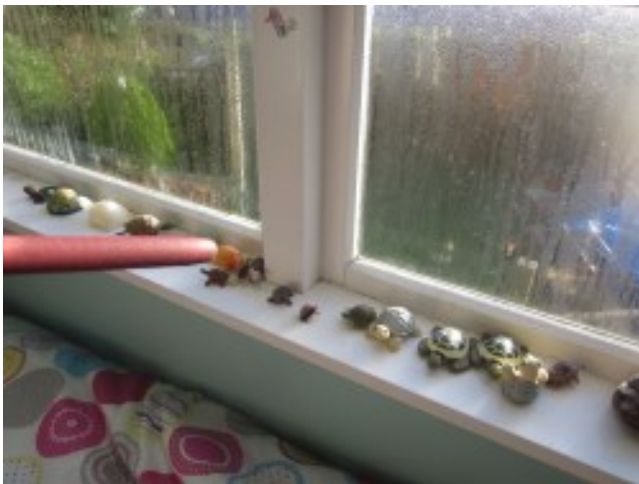
Windows needs easing minor maintenance

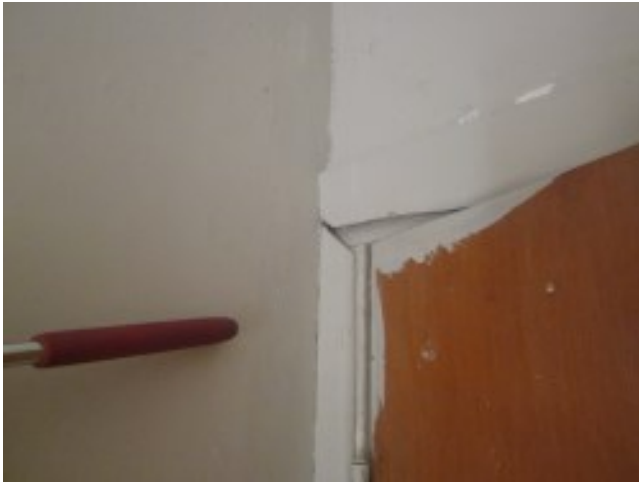
Door trim shows wear, will need attention

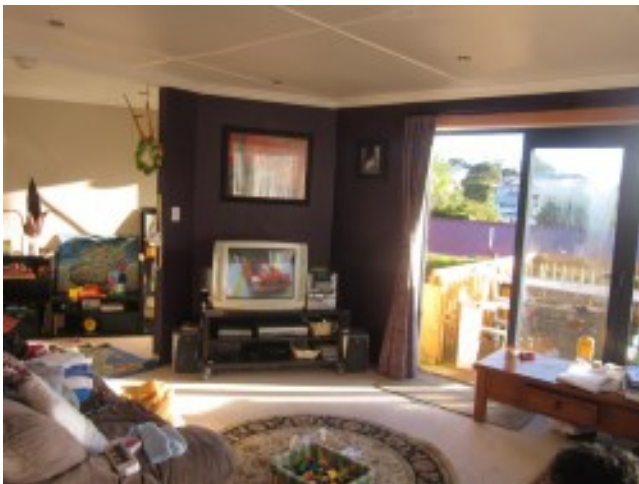
The lounge area appears in reasonable condition

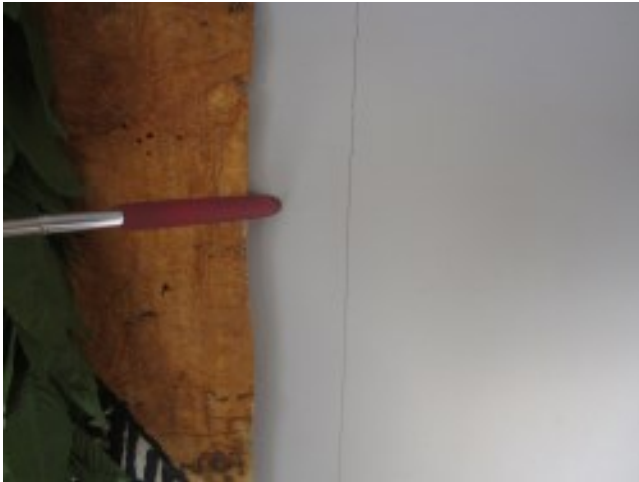
Movement cracking noted, very common to most homes

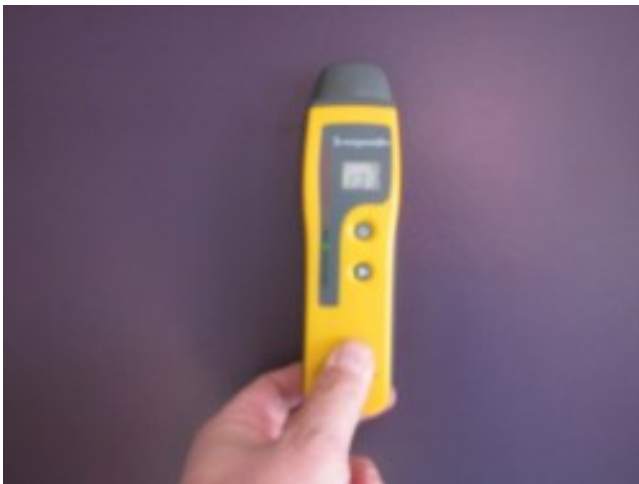
Moisture fluctuations to exterior walls appear normal

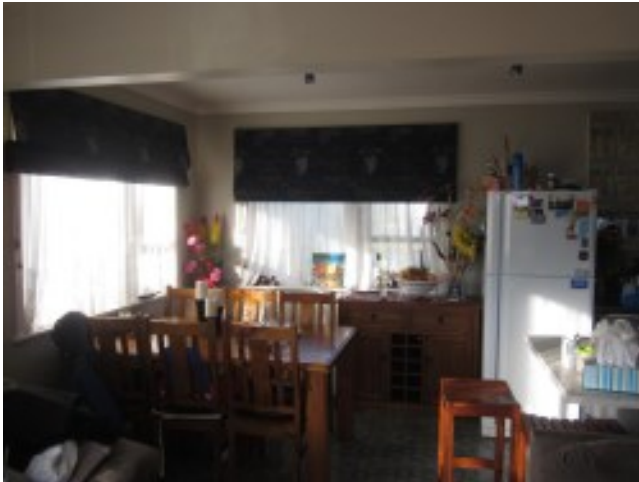
Dining room area appears in reasonable condition

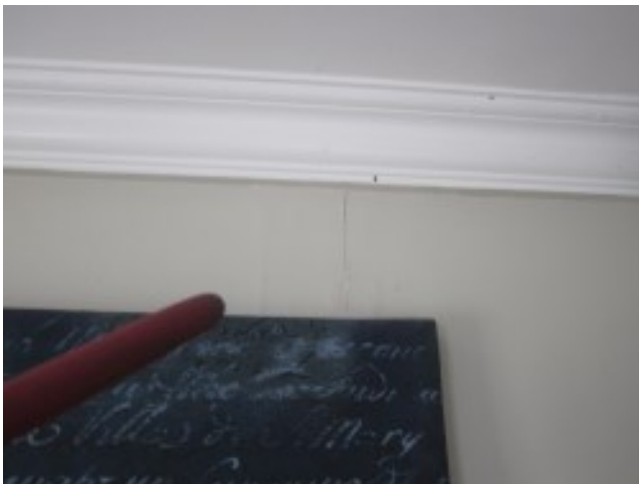
Movement cracking noted, very common to most homes

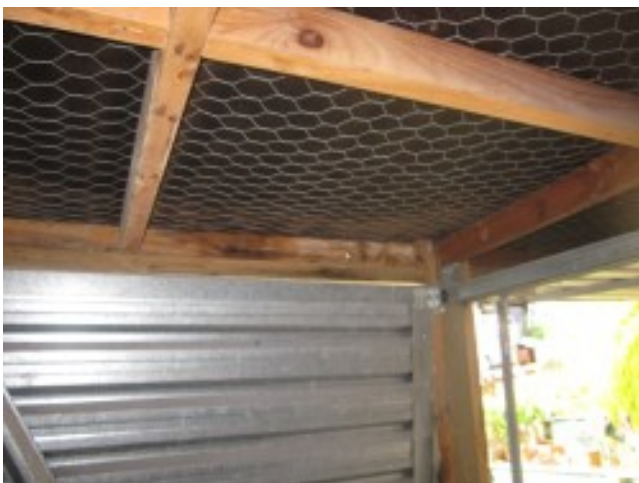
Wrong sized framing used to garage area, will need attention
